Item No. 15.6.3
Halifax Regional Council
November 12, 2024

SUBJECT: **Case HRTG-2023-01426: Substantial Alteration to the municipally registered heritage property at 86 Ochterloney Street, Dartmouth**

Heritage Impact Statement

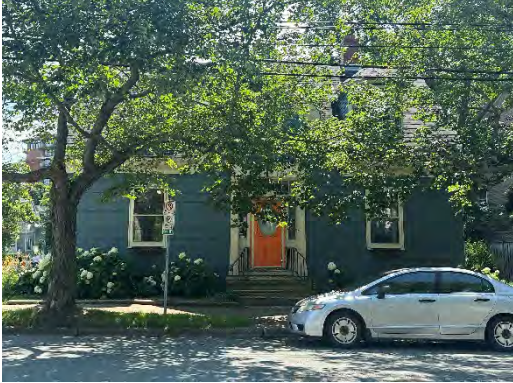
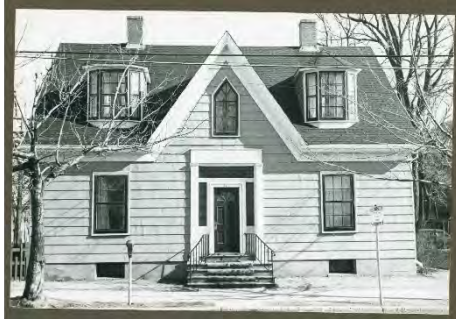
86 Ochterloney Street, Dartmouth

One-and-a-half storey, vernacular Gothic Revival style residence, including:

- Steeply pitched gable with centre pointed window flanked by two Scottish dormers on the north elevation;
- Steeply pitched gable with centre pointed window on the south elevation;
- Partial above-ground rubblestone foundation;
- Wood shingle cladding;
- Gable roof with wood returned eaves;
- Six-over-six windows with moulded trim;
- Single-leaf entrance surrounded by entablature with wood piers, multiple-light transom and sidelights;
- Two brick chimneys on the offset left and right.

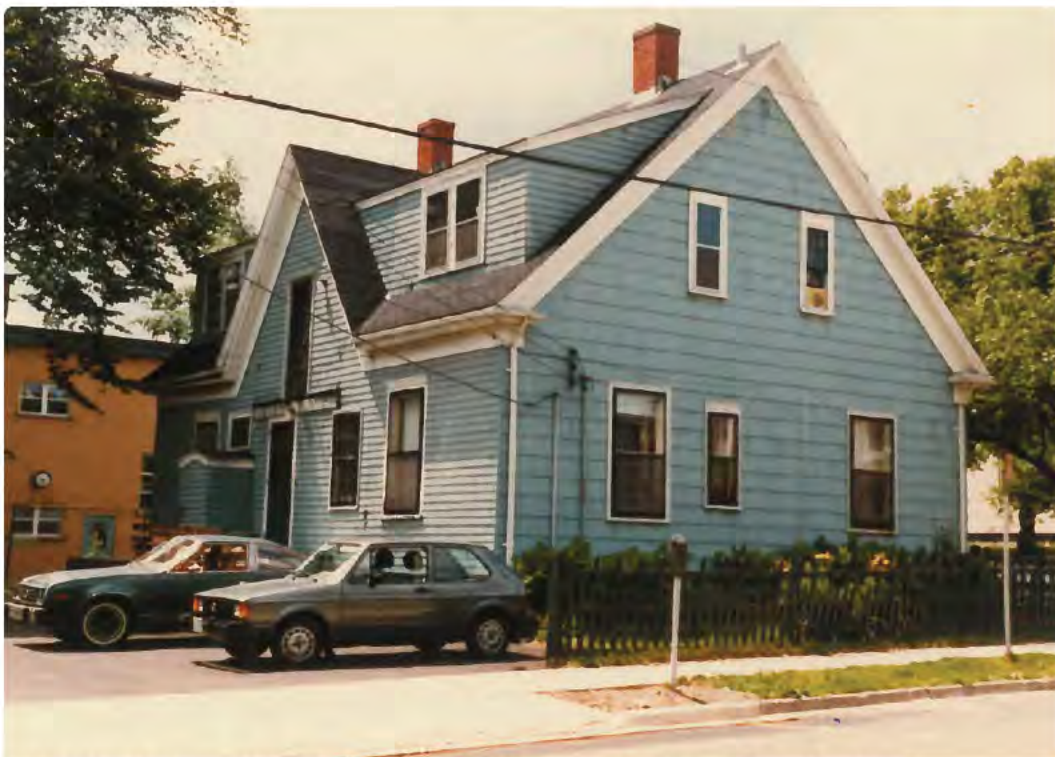
Figure 8: George and Mary Shiels Residence, seen from Dundas Street
Source: Municipal Research File, 1982

Covering the area east of the Dartmouth Common, there are a variety of 18th and 19th century buildings, which collectively illustrate the evolution of the area. The George and Mary Shiels Residence is one of those that contributes to this story. Initially researched back in 1981, it was added to the municipal register in 1982. The earliest photographs, from 1982 and 1986, show that it has changed little since that time (Figures 8 and 9).

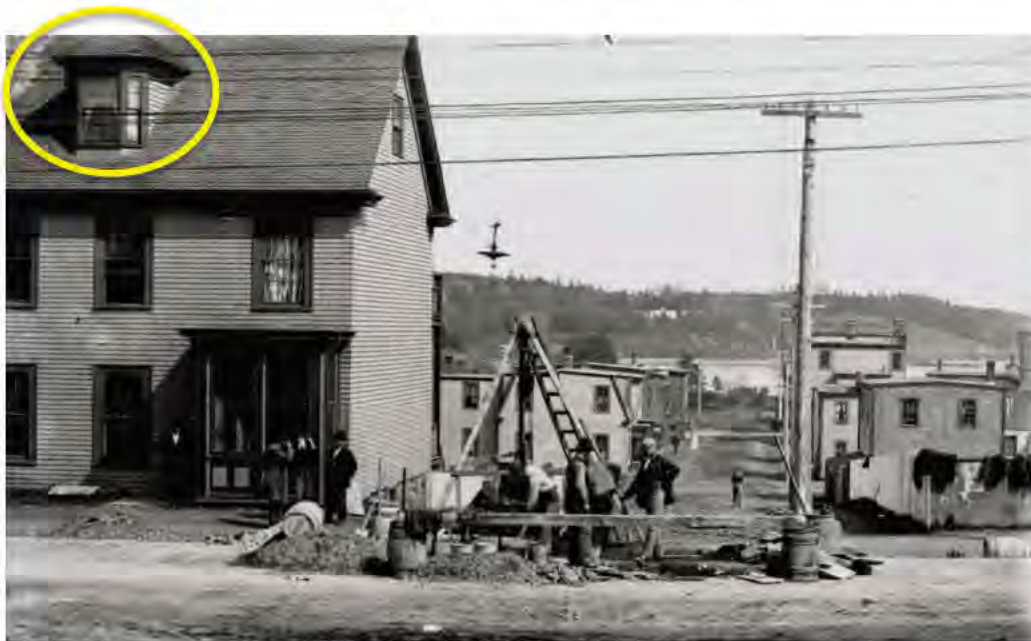
Figure 10: Victoria at Ochterloney – a house featuring the same Scottish dormers as the George and Mary Shiels Residence

Through the latter half of the 1800s, Ochterloney Street and the streets immediately surrounding it were developed with houses that were generally modest in size and unadorned when it came to detailing (Figure 10). This is less common for the Victorian era – a time when many highly decorative residences were built for the middle and upper class used expansive porches, gingerbread, shingles, posts and other elements.

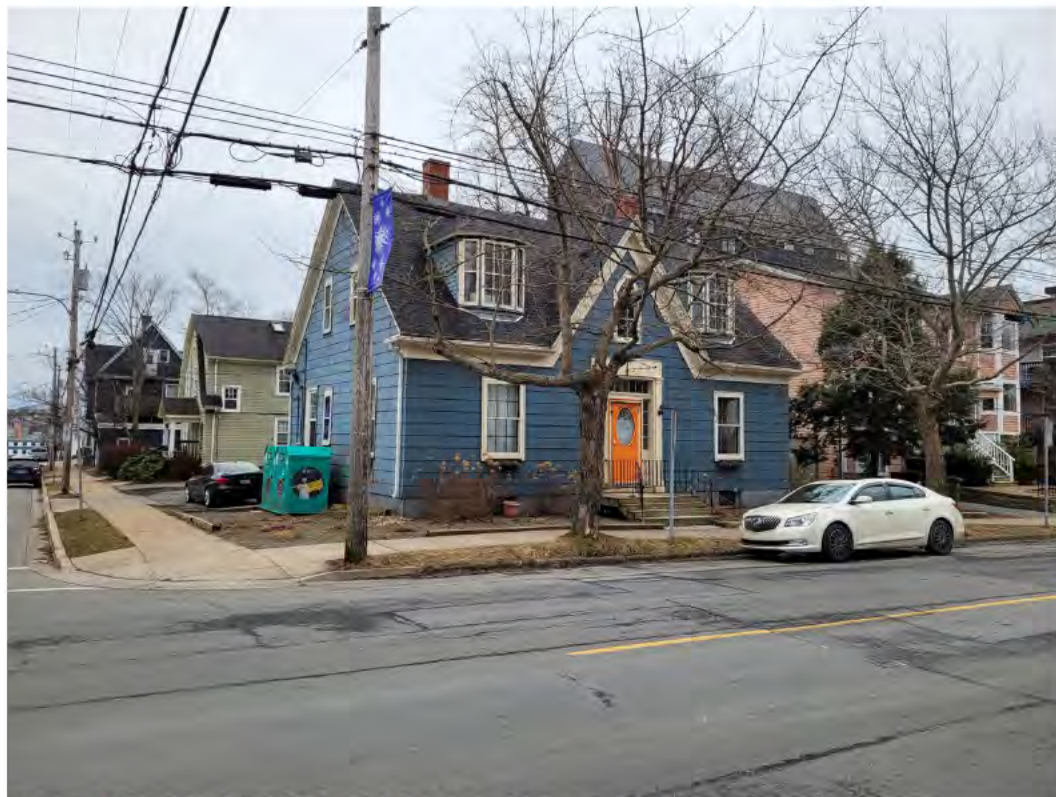
Figure 17: George and Mary Shiels Residence, 86 Ochterloney Street

Shortly after purchasing the lot, he had this house built on the corner, facing Ochterloney Street. The boundaries of the parcel are those that exist today. The house is a 1½ storey Vernacular Gothic Revival Style residence of the early Victorian era. Typical of this style, it features a central-set dormer on both the front and rear, with the main entry set immediately below the front gable (Figure 17).

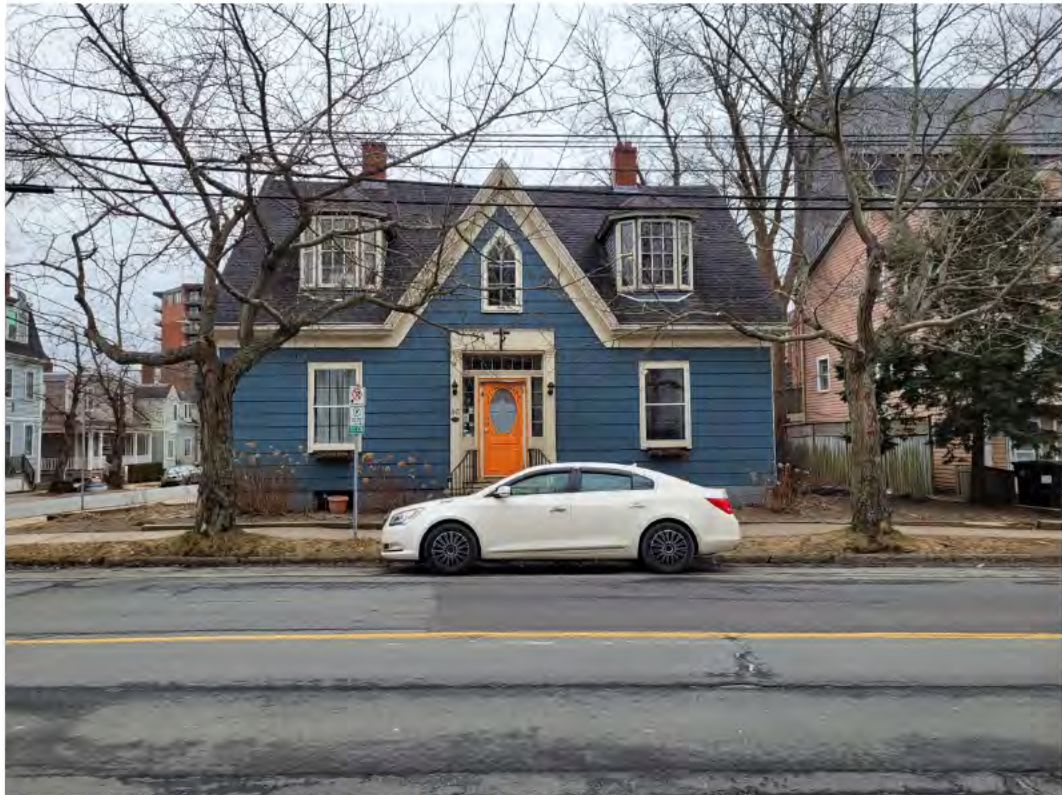
Figure 22a: George and Mary Shiels Residence, 86 Ochterloney Street – front

Overall, the integrity of the George and Mary Shiels Residence is good and reasonably intact. The large shingle cladding on the front and sides appears to be a newer layer, on the front and both sides (but not at the rear or on the front dormers). It likely covers earlier cladding, possibly smaller shingles (similar to those at the rear), although further investigation is necessary. The shingles at the rear are notably weathered, whereas those on the other front and two sides are in reasonably good condition, as are those on the front dormers.

The front door and sidelights are original. The double-hung front windows on the main floor, and the upper dormers, are original, with multi-panes in both the upper and lower sashes. The decorative fixed window in the central-set gable is original and features a multi-pane arrangement typical of this era. On the west and east sides, main floor, the larger openings have been replaced with vinyl windows with imitation muntins in between the panes. There are several other smaller openings with wood sash windows; these may be later additions or original. On those sides, upper floor, there are smaller-set window openings that are likely original, with vinyl replacement windows.

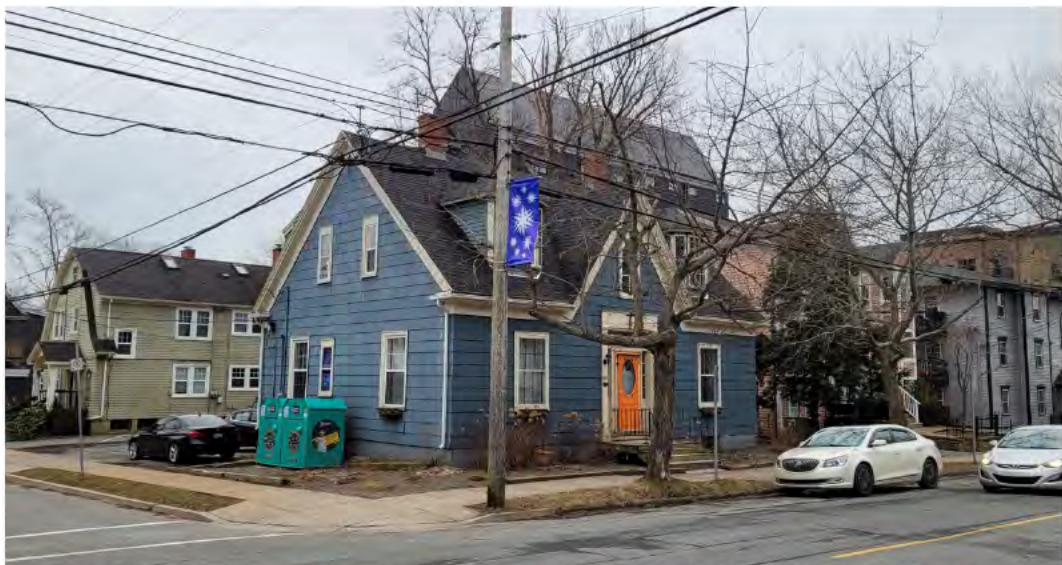
Figure 22b: George and Mary Shiels Residence, 86 Ochterloney Street – front and east side

Its side-gabled form is common to the Vernacular Gothic Revival style, with a steep-pitched central-set gable on both the front and rear and a small hipped roof dormer on either side of the front with narrow windows set at an angle, creating a “bay” – a design trait shared by other houses in the area of that vintage (see Section 2.1) – these are locally known as Scottish dormers.

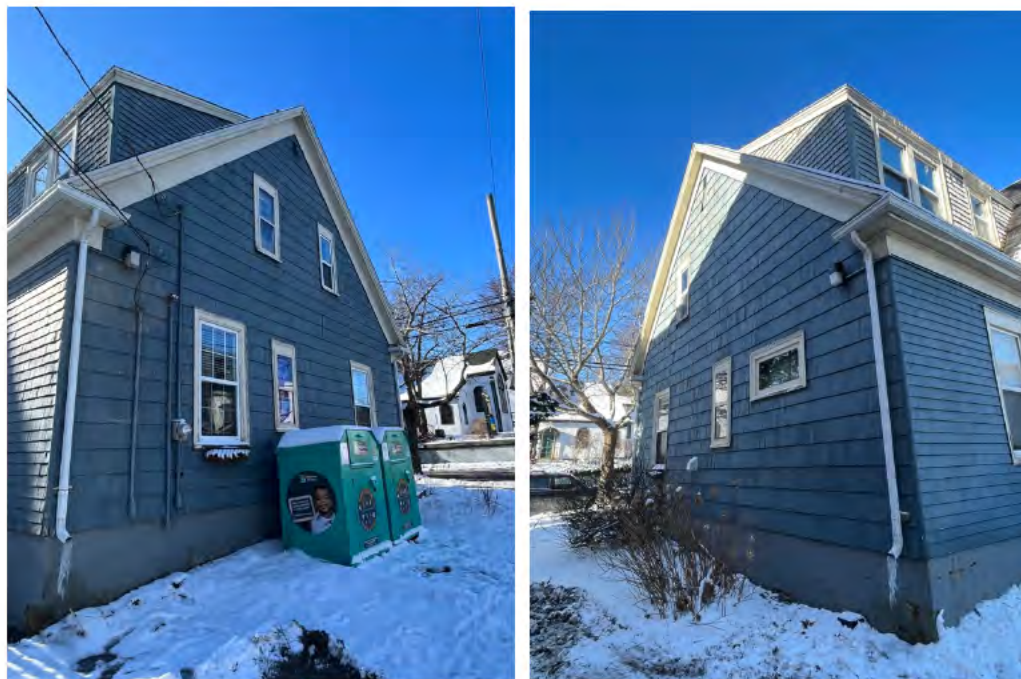
Figure 22c: George and Mary Shiels Residence, 86 Ochterloney Street – east and west sides

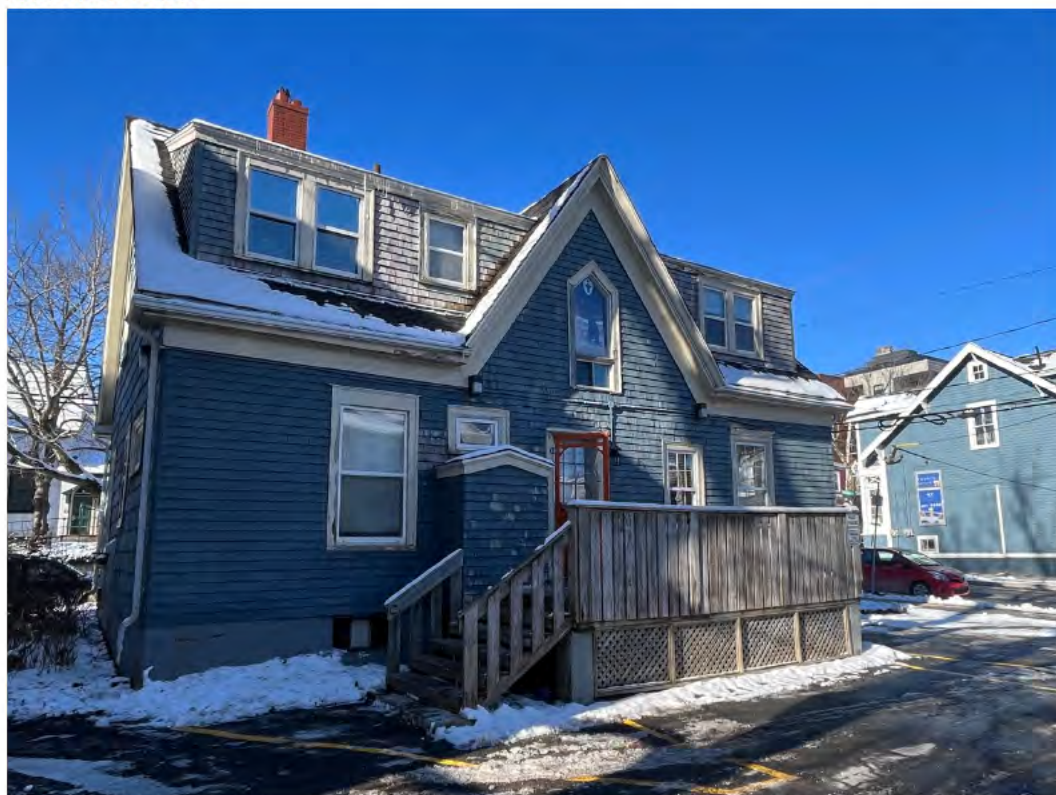
Figure 22d: George and Mary Shiels Residence, 86 Ochterloney Street – rear

At the rear, the entry door and the two larger window openings on either side of the door appear older or may be original to the house, while the smaller windows are likely alterations. All windows on the rear are vinyl replacements.

The shed dormer straddling the central gable appears to be a later addition based on the form and the paired window pattern, which contrasts with most of the large single-set windows elsewhere on the house. Fire Insurance Plans also show a small enclosure at the rear, which has been removed. The window set in the rear gable has been removed, although the opening remains intact. It was likely the same design as that on the front but is now a single pane with an inset slider. The condition of the window sashes is good, but many sills and trim are in fair to poor condition and will likely require repair or replacement.

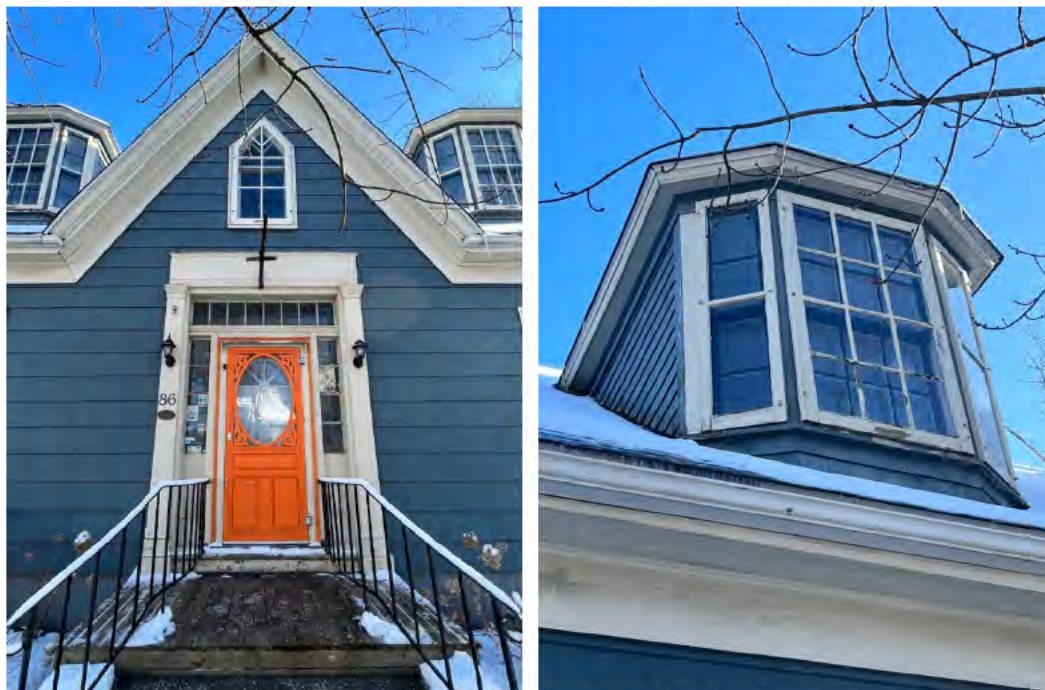
Figure 22d: George and Mary Shiels Residence, 86 Ochterloney Street – Front detail including entry, sidelights and transom, and central-set gable; upper window detail – Scottish dormers

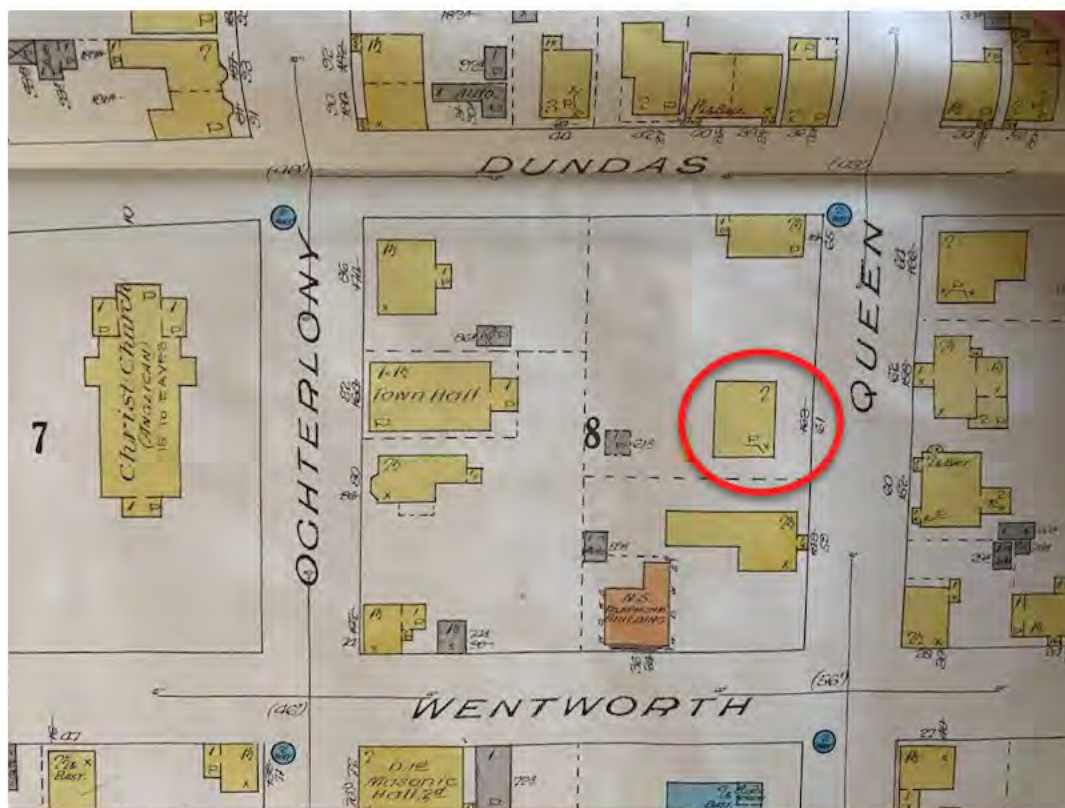
Figure 23: 1927 Fire Insurance Plan

The construction of the Alexander and Maude MacKay Residence at 61 Queen Street in 1899⁸ reflects the delayed development pattern of this block, where much of the surrounding blocks had already undergone development and been largely filled in. This is reflected in the 1927 Fire Insurance Plan (Figure 23).

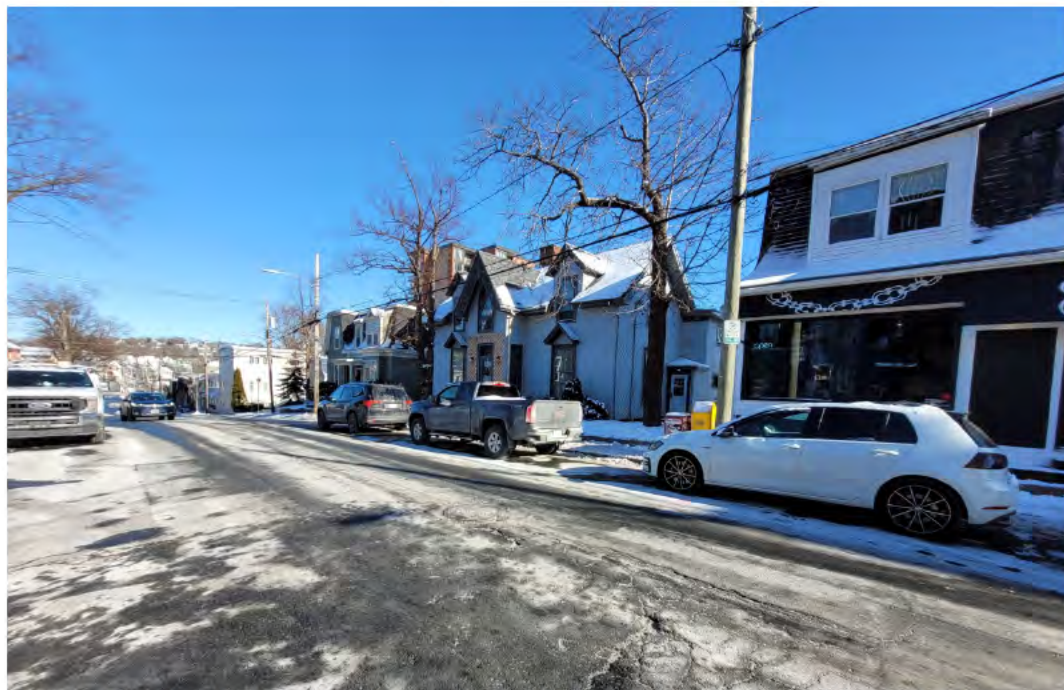
Figure 27a: Context of the Alexander and Maude MacKay Residence, looking northeast along Queen Street

Similar to the George and Mary Shiels Residence, it has minimal setback from the street, with more ample room at the rear, a narrow south side yard, along with turn-of-the-century housing located to the north (Figure 27) with generous spacing between, and a communications building located to the south with a much narrower side yard.

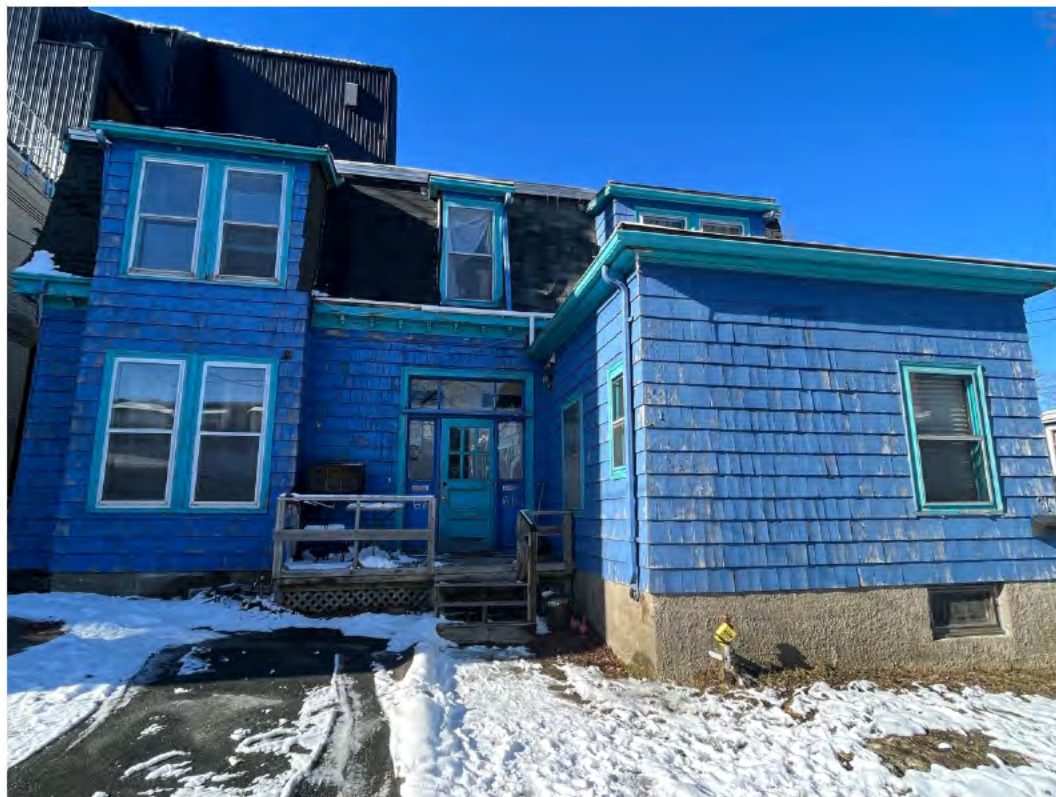
Figure 28a: Alexander and Maude MacKay Residence, 61 Queen Street – front, with later office extension shown on the right

Its form is defined by its low-slope side-gable roof which slopes dramatically on the front face, in the Mansard form, and its symmetrical placement of the entry and flanking double-height protruding square bays on the front, which all speak to a simplified version of the Second Empire. However, it is simplified in that it does not have heavily bracketed cornices, quoins or balustrades typical of that style, and the Mansard roof form is missing at the rear.

These elements are illustrated in Figures 28a to 28d.

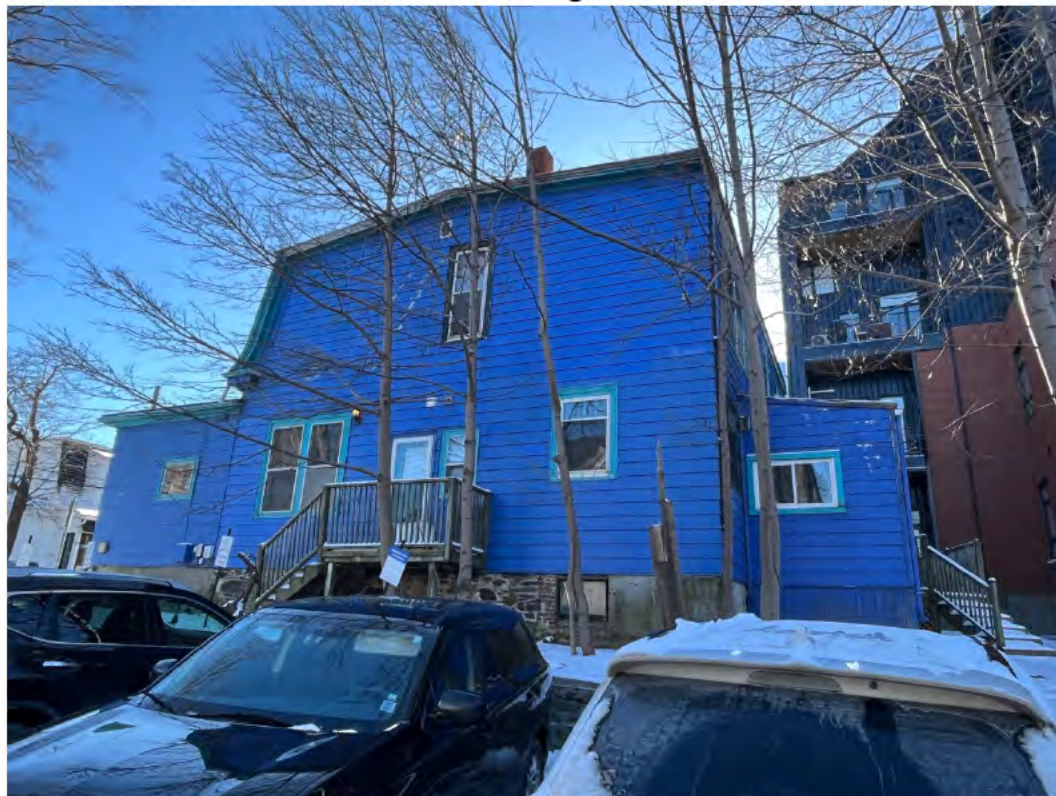
Figure 28b: Alexander and Maude MacKay Residence, 61 Queen Street – east

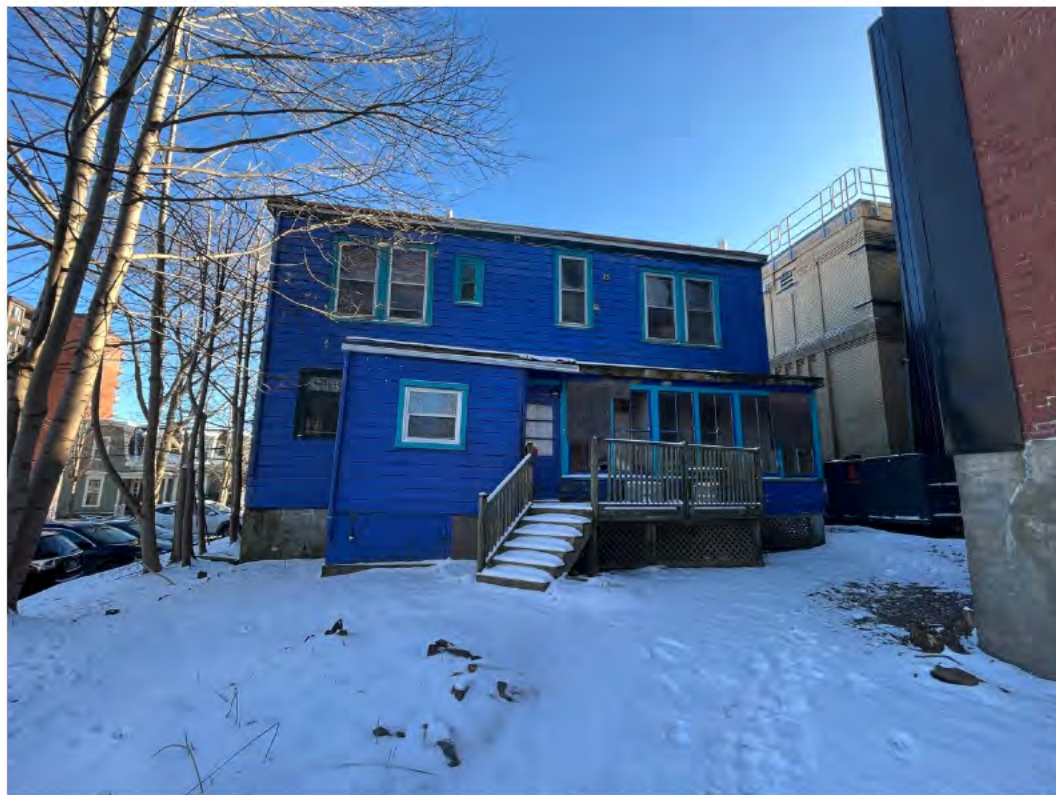
Figure 28c: Alexander and Maude MacKay Residence, 61 Queen Street – rear

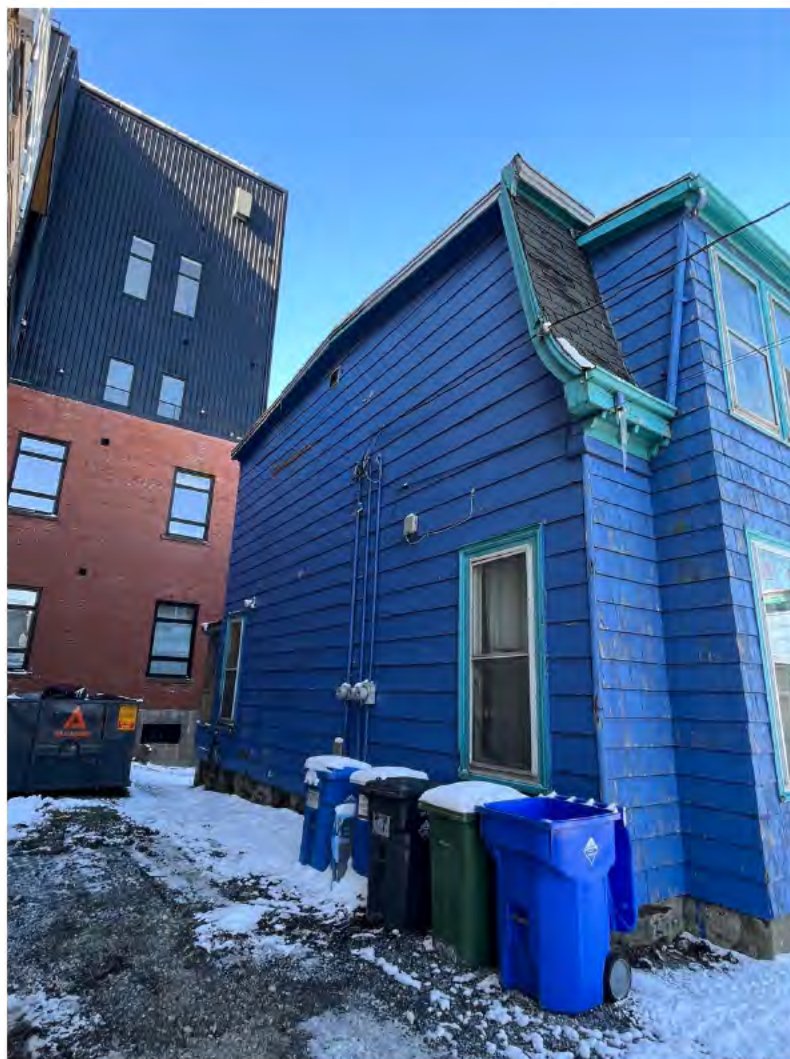
Figure 28d: Alexander and Maude MacKay Residence, 61 Queen Street – west

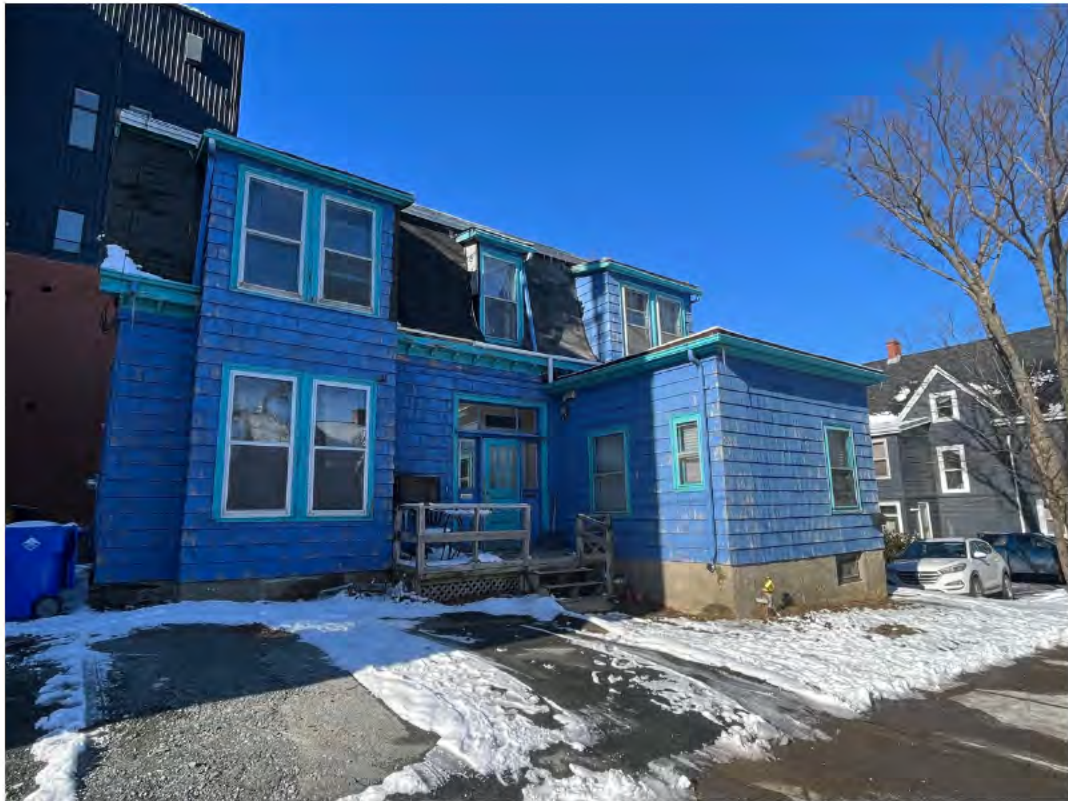
The single-storey front office accommodating the office of Dr. Ernest Glenister, added c. 1930, is the most notable alteration on this building. This takes away from the symmetry of the Second Empire Style, and covers up much of the right side including the lower half of the double-height squared bay. The purpose of this addition was purely functional, as Dr. Glenister required an office that would be easily accessible for the public without having to pass through his home. The privacy of his home was retained but the overall integrity of the building was compromised significantly. Further alterations since that addition include the filling in of the office entry with shingles to match those of the rest of the house; however, the section where the entry door was situated is still noticeable. The front porch has been replaced – the form and function of any original porch is not known, but the existing uncovered porch similarly detracts from the overall design of the house (Figure 29a).

Figure 29a: Alexander and Maude MacKay Residence, 61 Queen Street – front extension and porch

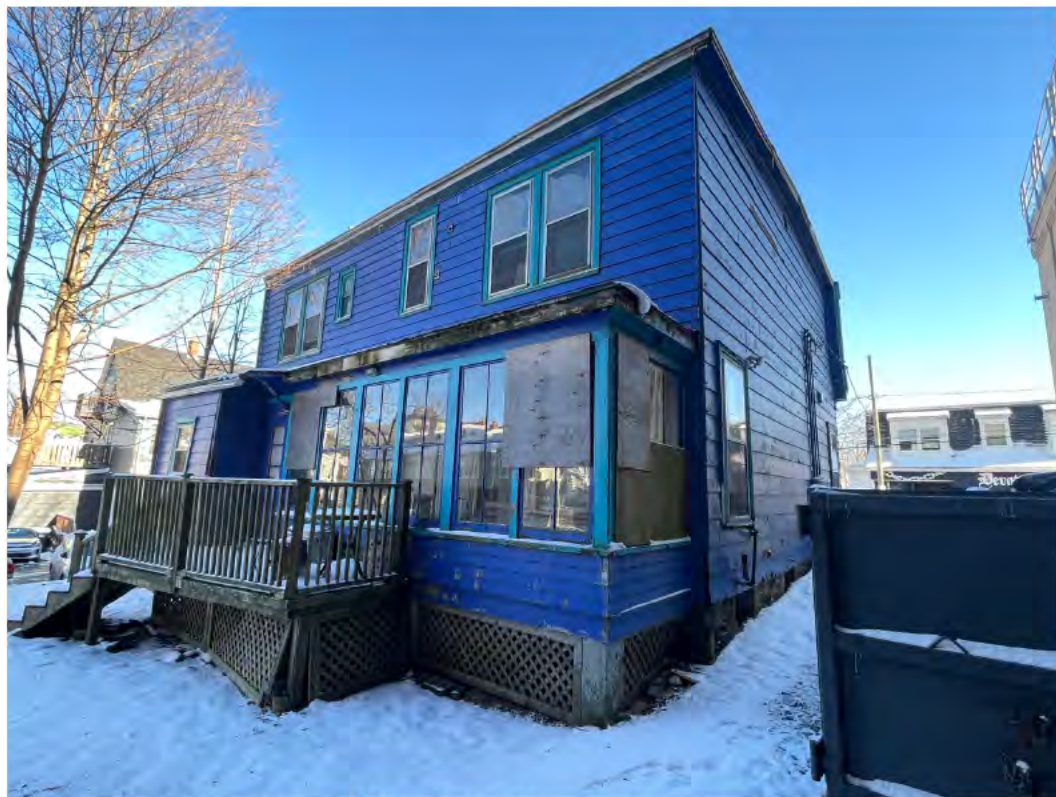
In addition the rear porch has been enclosed and a further open porch extension has been added. The original windows set on the rear wall face, with sills and trim, are visible within that rear enclosure (Figure 29b).

Figure 29b: Alexander and Maude MacKay Residence, rear porch enclosure

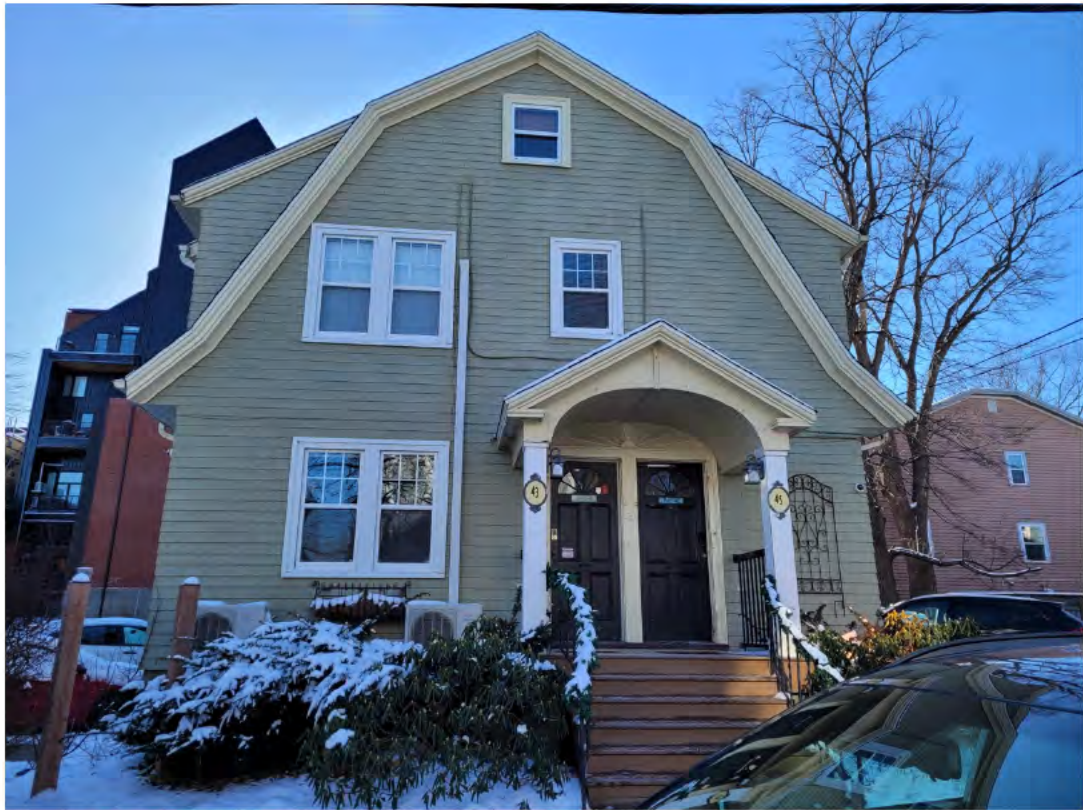
Figure 33a: 43-45 Dundas Street, front

Presented in the Dutch Colonial Revival Style, 43-45 Dundas Street stands out among its surroundings as a much more modern style popular in the inter-war period (Figures 33a to 33d). The two entry doors on the west side added as part of its conversion to a multi-unit building is the most noticeable alteration.

It is defined by its steep pitched front-gable roof which creates the illusion of a “barn” form roof that is characteristic of the Dutch Colonial Revival style. It has a two-storey form, with a double-height bay window on the south side, paired double-hung windows on the north side and a paired entry with an arched overhang porch cover.

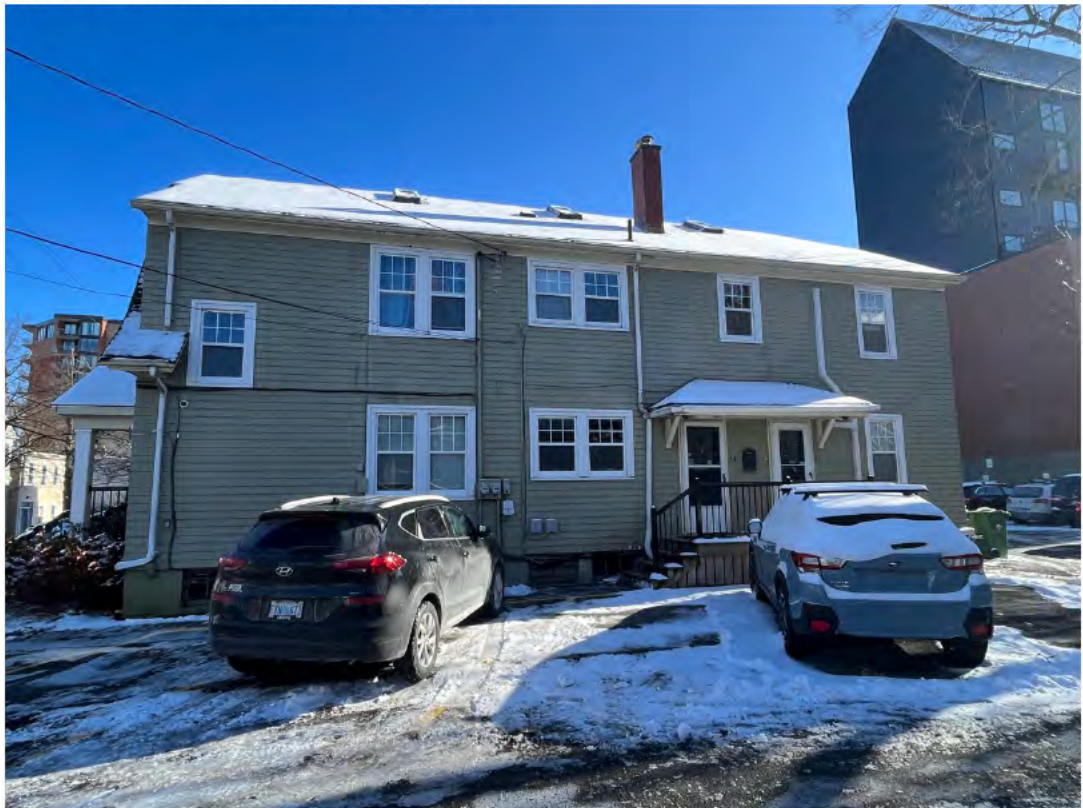
Figure 33b: 43-45 Dundas Street, north

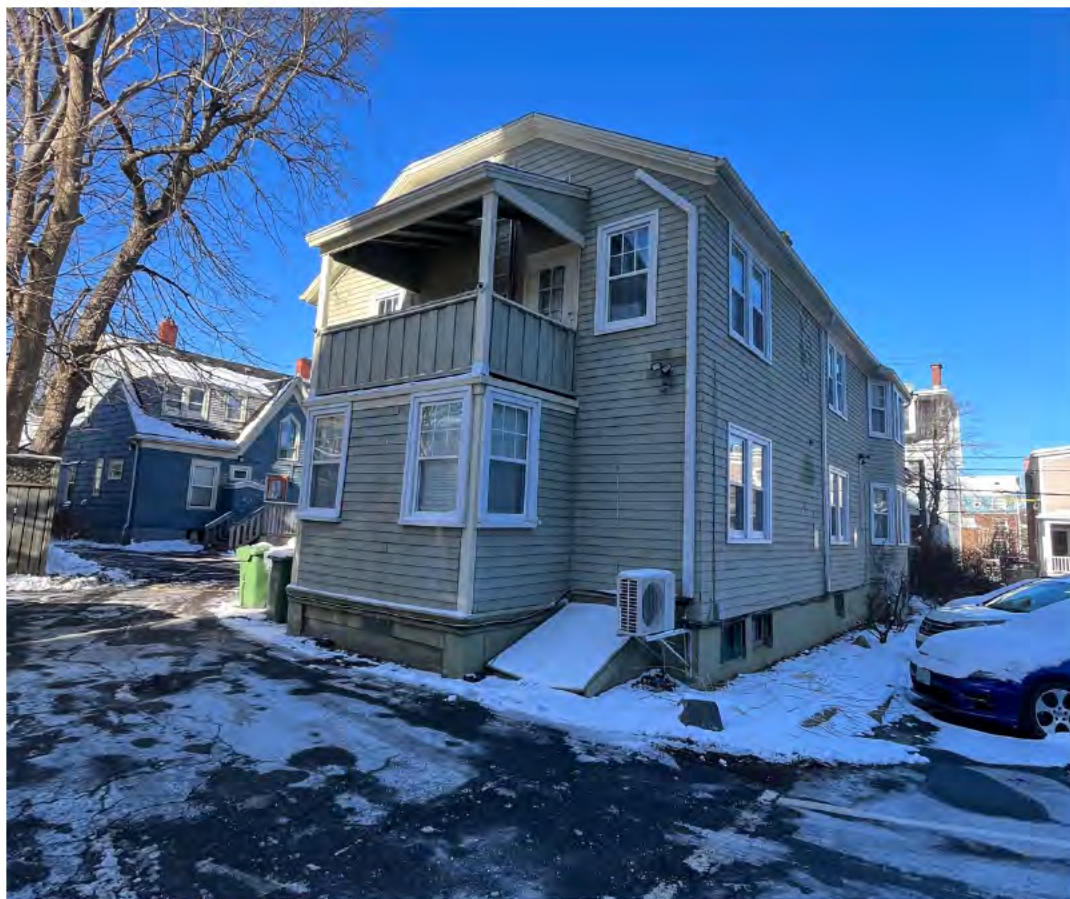
Figure 33c: 43-45 Dundas Street, rear

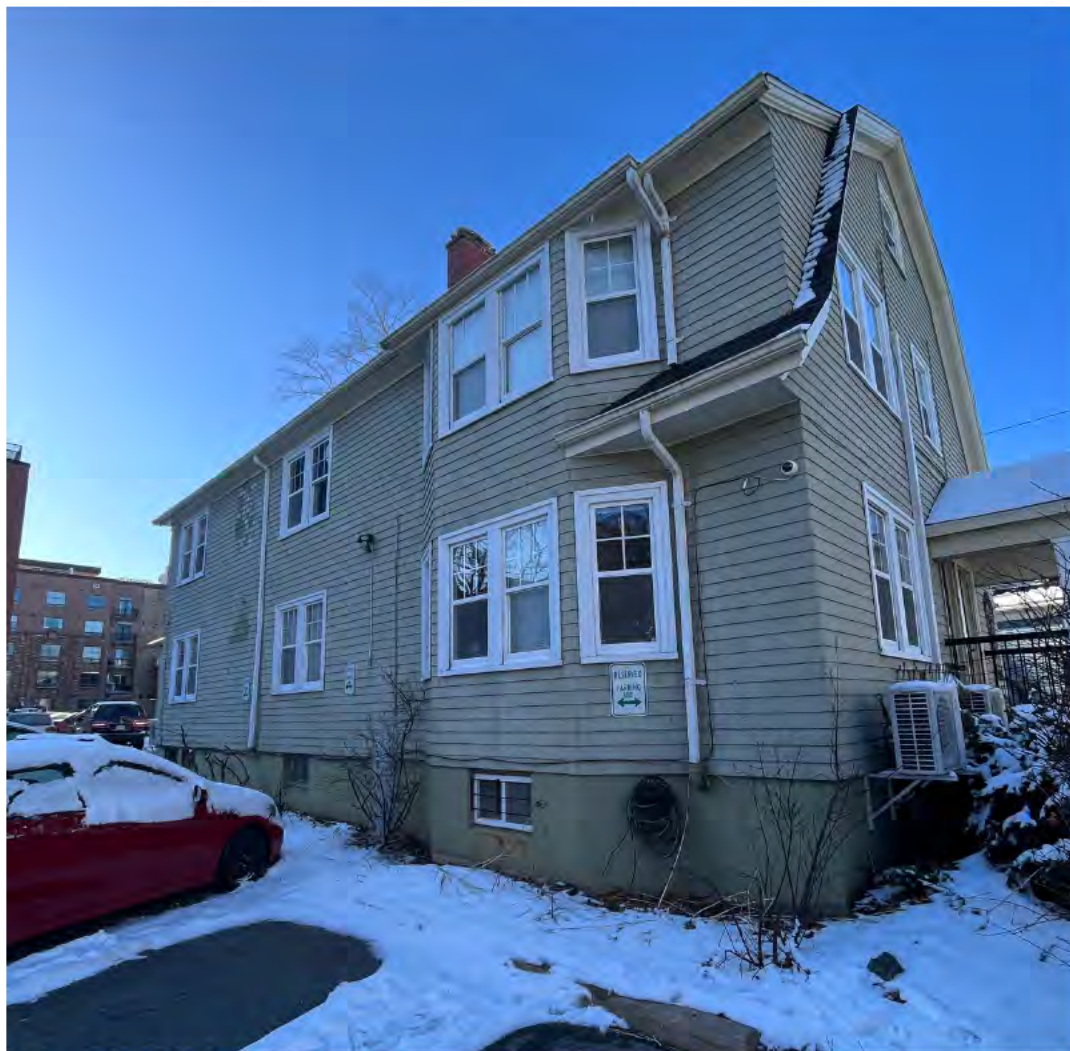
Figure 33d: 43-45 Dundas Street, south

The house follows some of the traditional symmetrical form of this style, set near ground level with its double-pitched gambrel “barn” roof. However, it deviates from this style’s common orientation: its barn gable is on the front instead of the side. These kinds of houses are typically set length-wise (on a wider lot) with the gable set the sides. Due to this orientation, the entry, normally set centrally on the long side, is set at the end, and is off-set to the right. Finally, another characteristic of the Dutch Colonial Revival Style is that a soffit extends the full frontage, above which is set either a series of shed dormers, or a single shed dormer inset notably from the side gable wall and softens the massing, and essentially gives it a 1½ storey form. 43-45 Dundas Street again deviates from the norm: it has no soffit along the long sides, and expansive dormers that extend fully to the gable wall and minimize the distinctive double-pitched gambrel roof, and effectively create a two-storey massing. Finally, this style normally exhibits at least one (usually two) sets of expansive windows (generally a tripartite arrangement) flanking the central-set main entry. While the double-

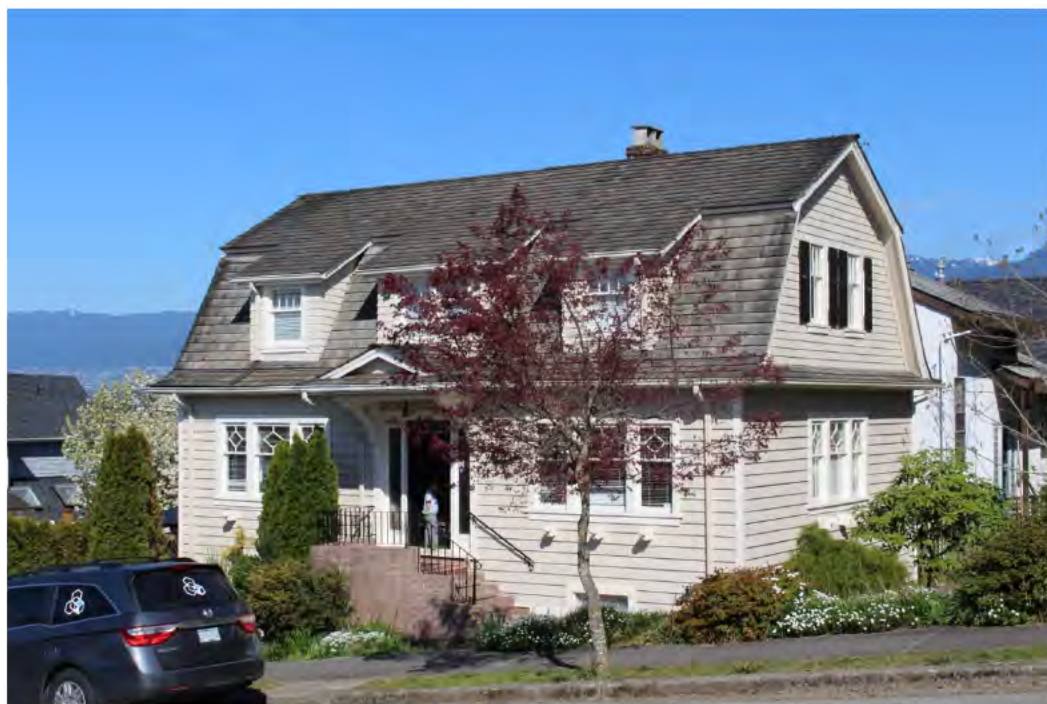
Figure 35: 3593 Oxford Street, Vancouver, which exhibits many of the traditional form and design characteristics of the Dutch Colonial Revival Style. Source: Author's Personal Collection, 2016

Its wood shingle cladding, porch design and window type (double-hung) are a good representation of the Dutch Colonial Revival Style. However, as a broader representation of this style, its form and lack of symmetry, along with some its other elements, such as the lack of a continuous soffit, do not showcase or soften the massing and fail to provide a distinctive appearance between the first and second floor. These points are illustrated in Figure 35.

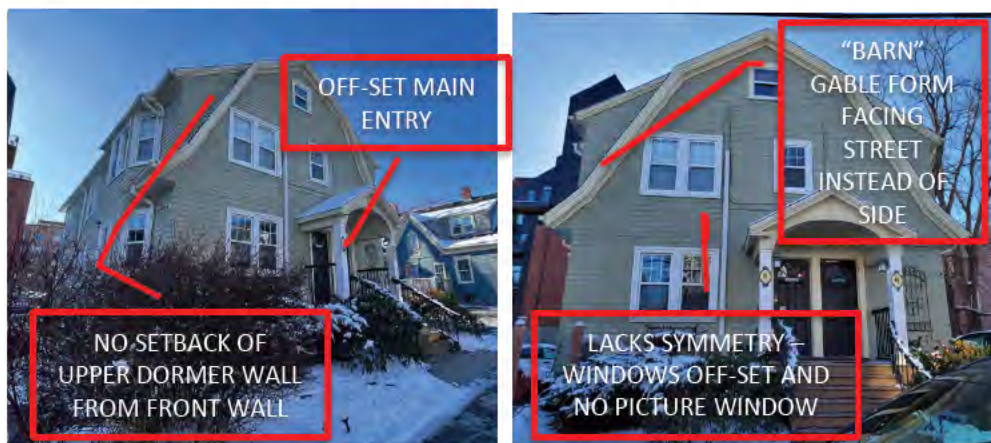
Figure 36a: Front components of 43-45 Dundas Street that detract from the style and overall design of a Dutch Colonial Revival house.

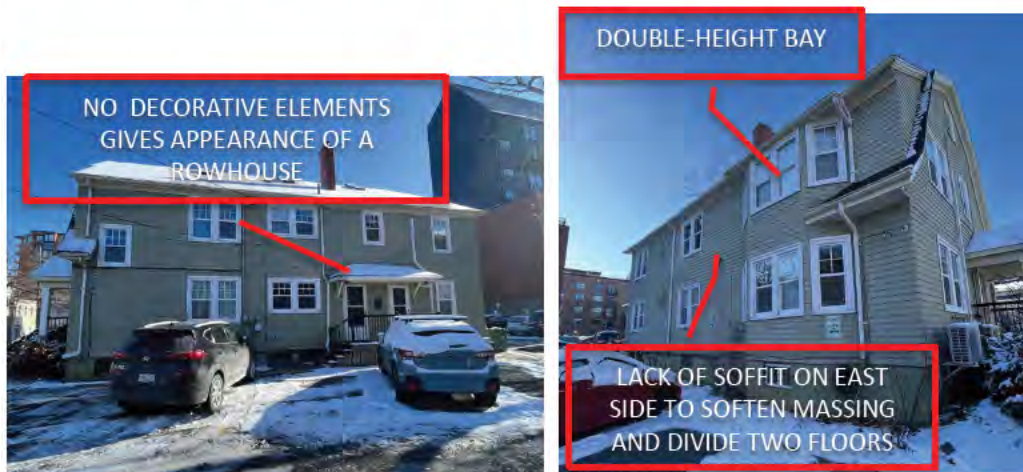
Figure 36b: Side components of 43-45 Dundas Street that detract from the style and overall design of a Dutch Colonial Revival house.

The house at 43-45 Dundas Street appears to be in very good condition and it retains its exterior integrity, including its dual entry – reflecting that it was purpose-built as a duplex – along with its windows, cladding and decorative covered entry porch, with an arched ceiling and squared posts. Its most significant change has been the addition of two entry doors on the north side as a result of its multi-unit conversion. However, despite the overall integrity, and as noted in Section 3.3.2, it is not a particularly good representation of the Dutch Colonial Revival Style. The basis for this conclusion is illustrated in Figure 36.

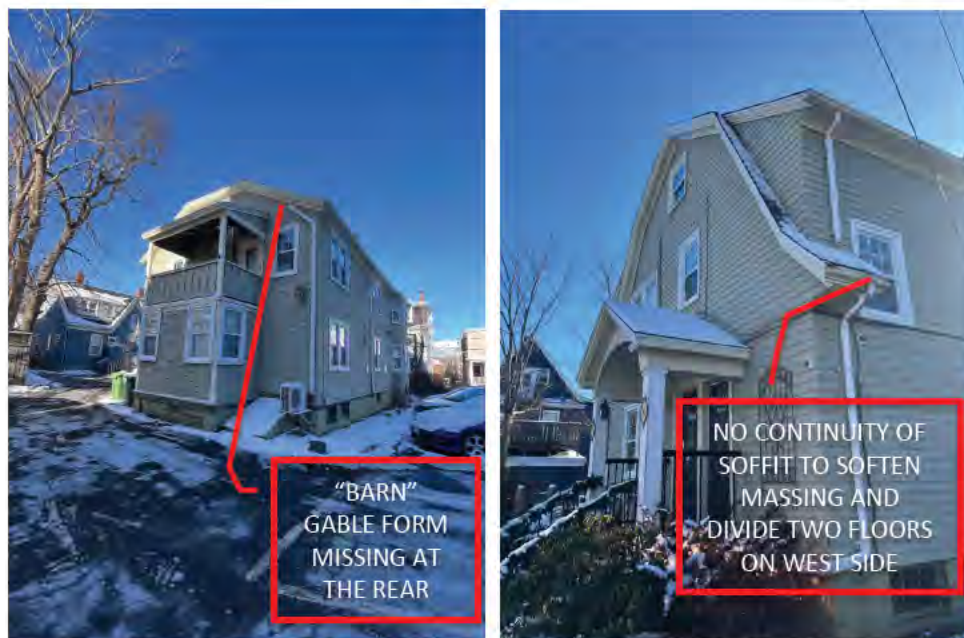
Figure 36c: Front and rear components of 43-45 Dundas Street that detract from the style and overall design of a Dutch Colonial Revival house.
