Item No. 15.6.3
Halifax Regional Council
November 12, 2024

SUBJECT: **Case HRTG-2023-01426: Substantial Alteration to the municipally registered heritage property at 86 Ochterloney Street, Dartmouth**

Heritage Impact Statement

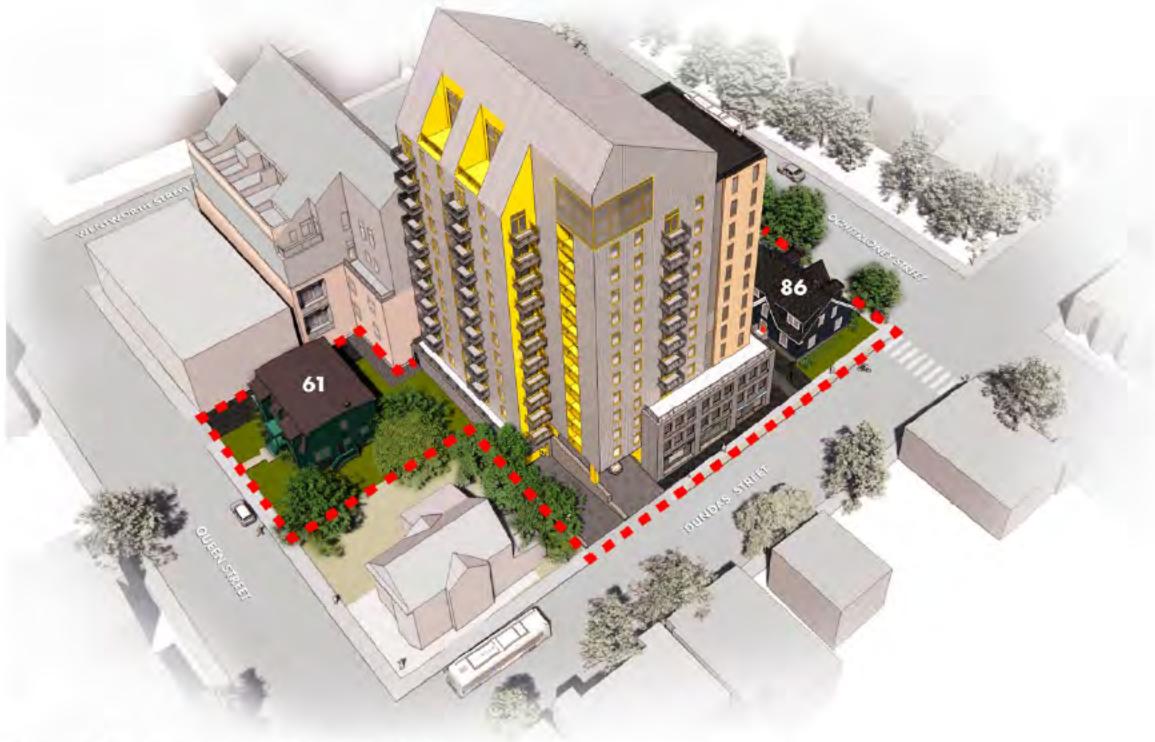
Figure 37: Proposed Site Development

A new multi-use building is proposed for the centre of the block fronting Dundas Street, comprising a 13-storey tower with 103 residential units, and a three-storey podium extension towards the front that includes one ground-floor commercial retail unit, with an overall FAR proposed at 5.2.

This development will require removal of the 1933 multi-unit residence at 43-45 Dundas Street, while the George and Mary Shiels Residence is, at the time of preparing this report, being considered for residential (its historic use) while the Alexander and Maude MacKay Residence will remain multi-unit residential (Figures 37 and 38).

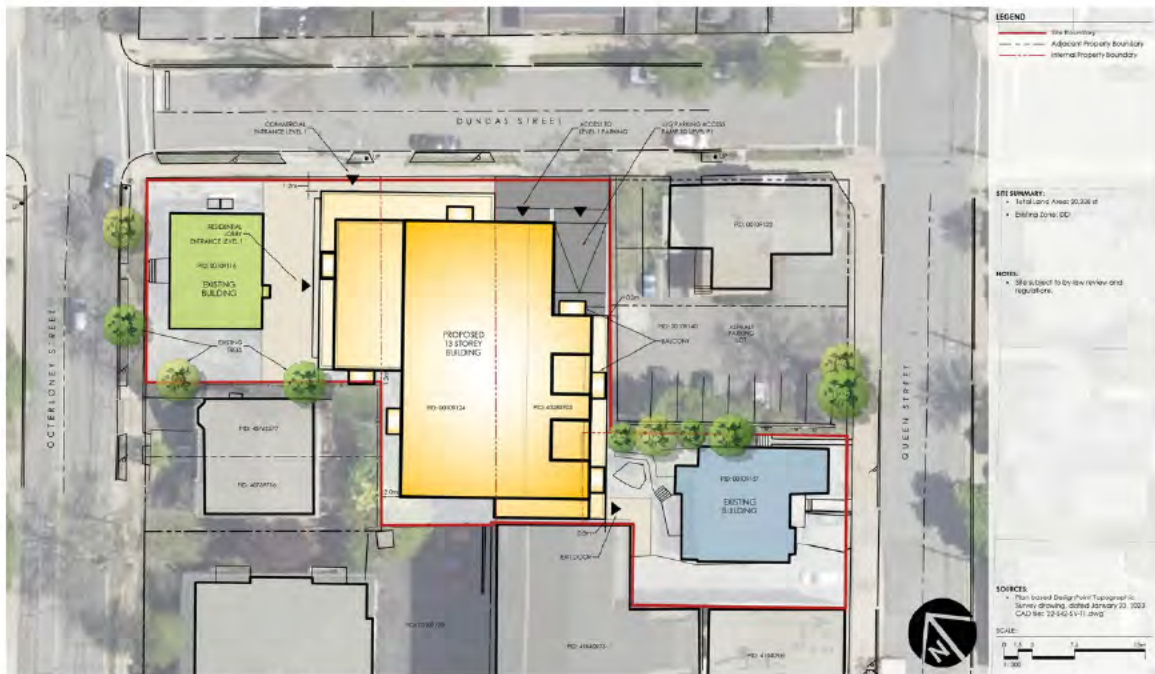
Figure 38: Proposed Site Plan

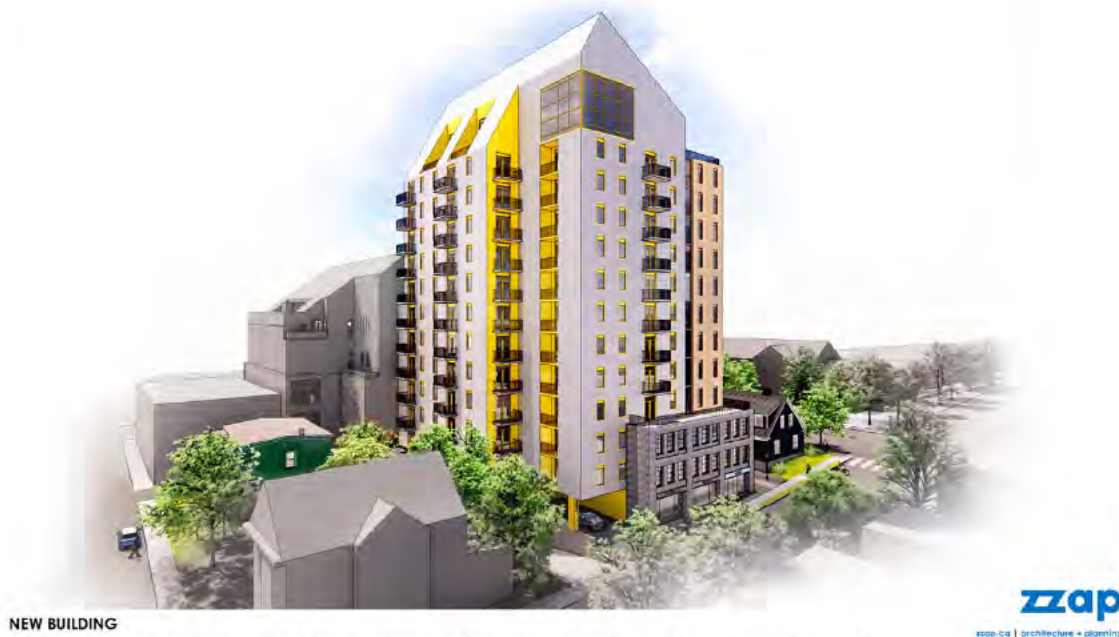
Figure 39: Proposed North Elevation (seen from Dundas Street)

These design concepts are illustrated on Figures 39 to 41.

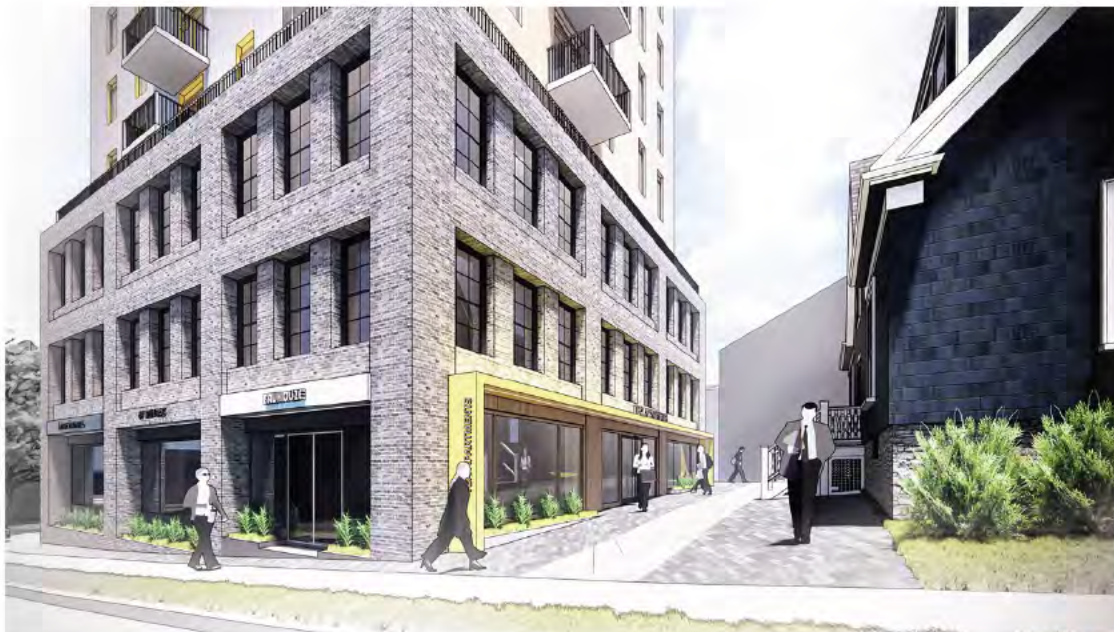
DUNDAS ENTRANCE

Figure 40: Proposed Dundas Entrance and relationship to the George and Mary Shiels Residence

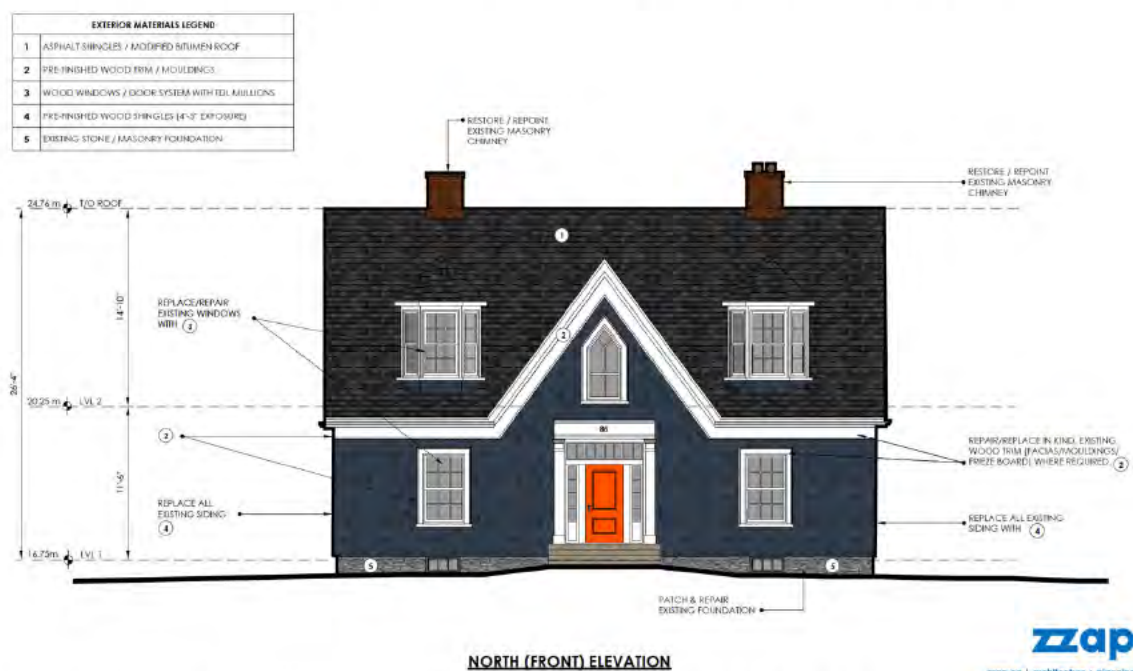
The George and Mary Shiels Residence will remain intact and, where necessary, restored to its historic appearance. This requires a combination of preservation, rehabilitation and restoration. The foundation and chimney will be preserved and repaired where necessary. The cladding will be restored on all sides to its original (wood shingles). All front windows, and the door and sidelights, original to the house, will be retained and rehabilitated, although the option to replicate remains if, upon further examination, the condition warrants. All wood trim – fascia, mouldings, frieze board – will be repaired or replaced in kind (Figure 42).

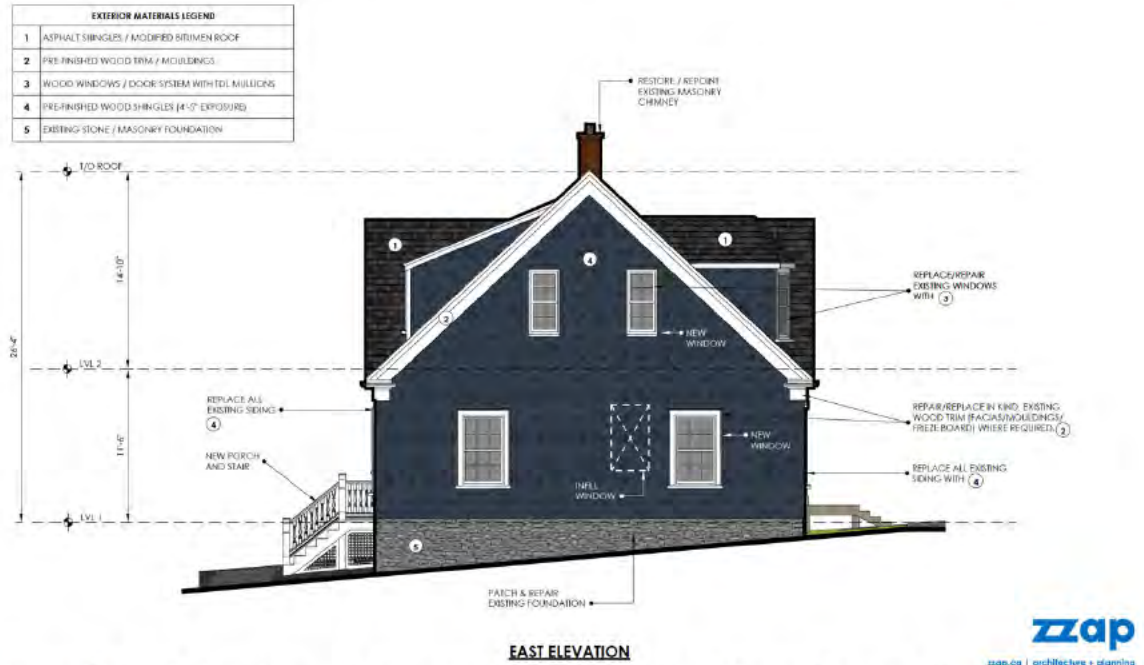
Figure 43: East Elevation – George and Mary Shields Residence (Restored)

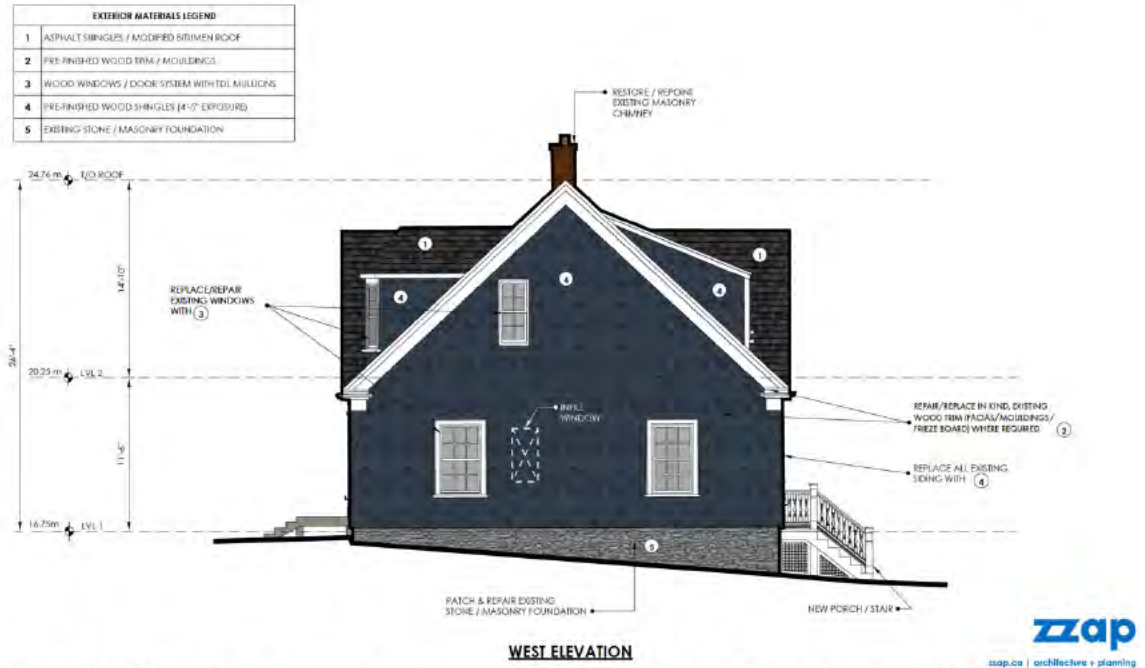
Figure 44: West Elevation – George and Mary Shiels Residence (Restored)

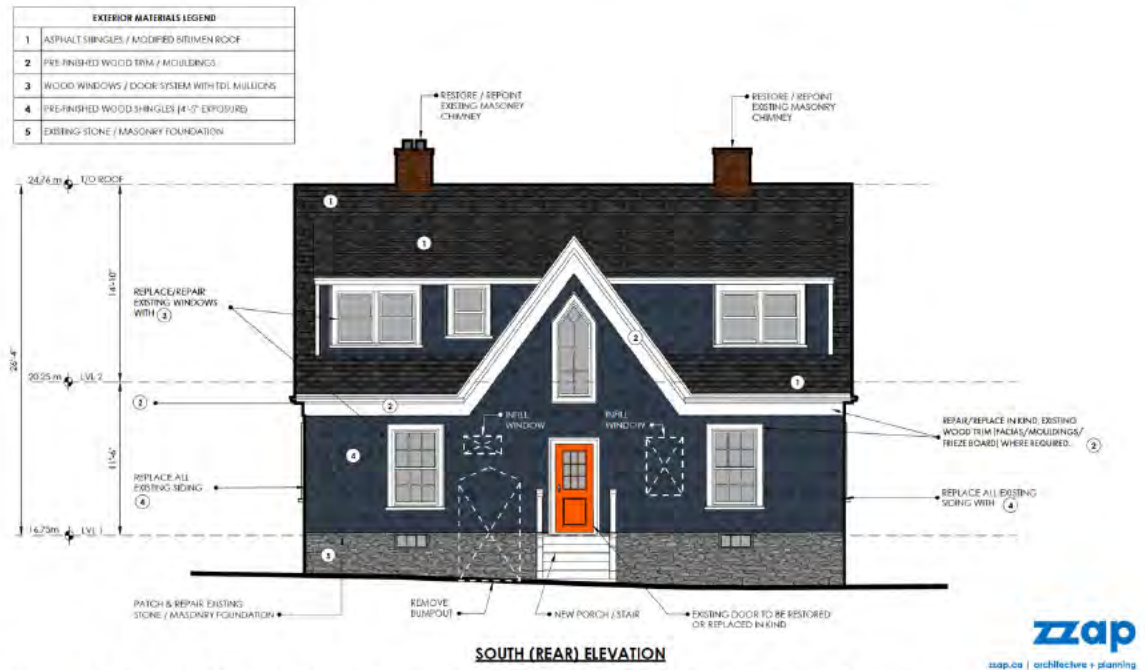
Figure 45: South (Rear) Elevation – George and Mary Shiels Residence (Restored)

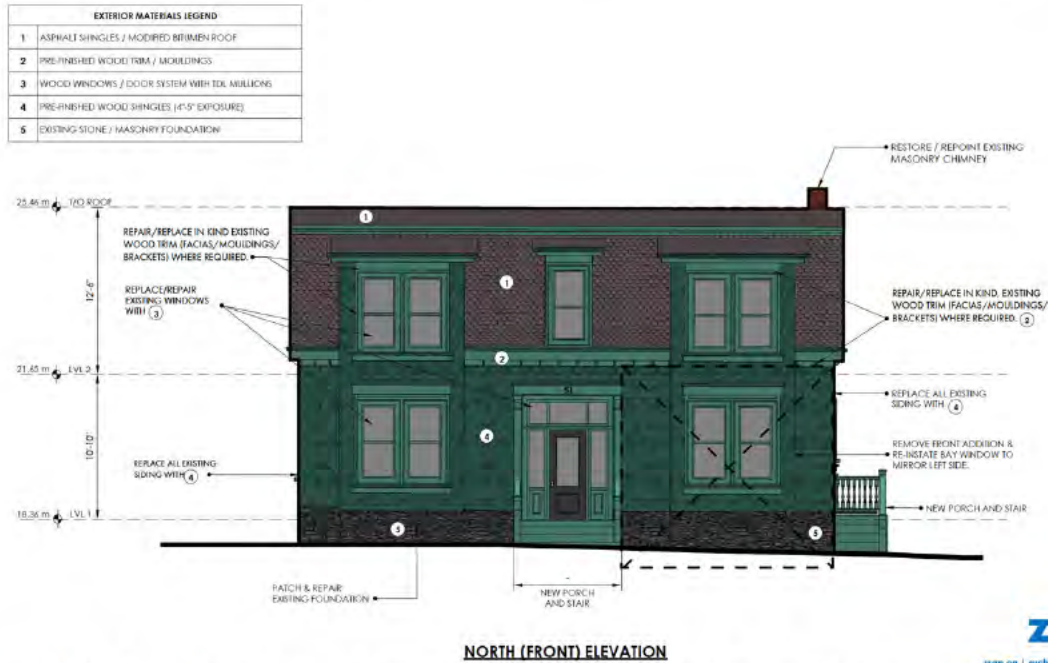
Figure 46: Front Elevation – Alexander and Maude MacKay Residence (Restored)

The front addition made in the 1930s will be removed and the wall face behind will be restored with cladding, windows and trim to match that of the intact left side (Figure 46).

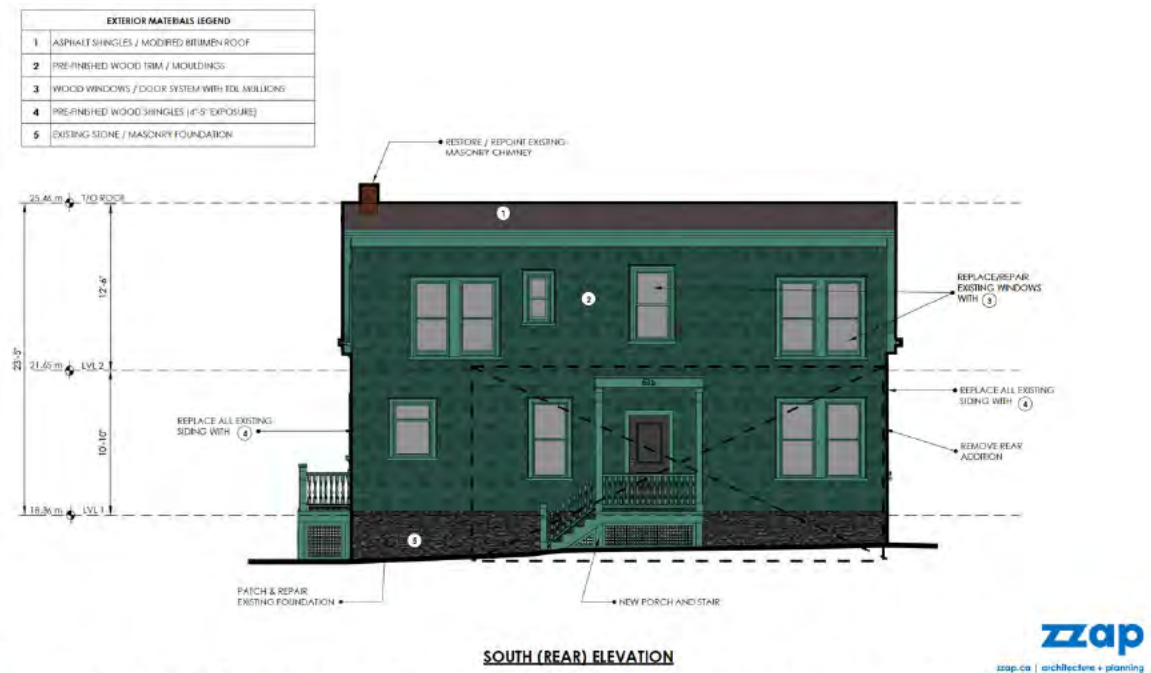
Figure 49: South (Rear) Elevation – Alexander and Maude MacKay Residence (Restored)

On the south elevation, the porch enclosure and the rear extension to the left of the porch will be removed, with restoration of the rear wall comprising cladding, trim, windows and doors. The remainder of windows on the main and upper floors will be rehabilitated, with any necessary repair of deteriorated material (Figure 49).

On the west (rear) elevation, the most significant alteration, comprising the porch enclosure and the rear extension to the left of the porch, will be removed, with restoration of the rear wall cladding, trim, windows and doors. The window on the main floor, far left, and the upper floor windows will be rehabilitated, with any necessary repair of deteriorated material.

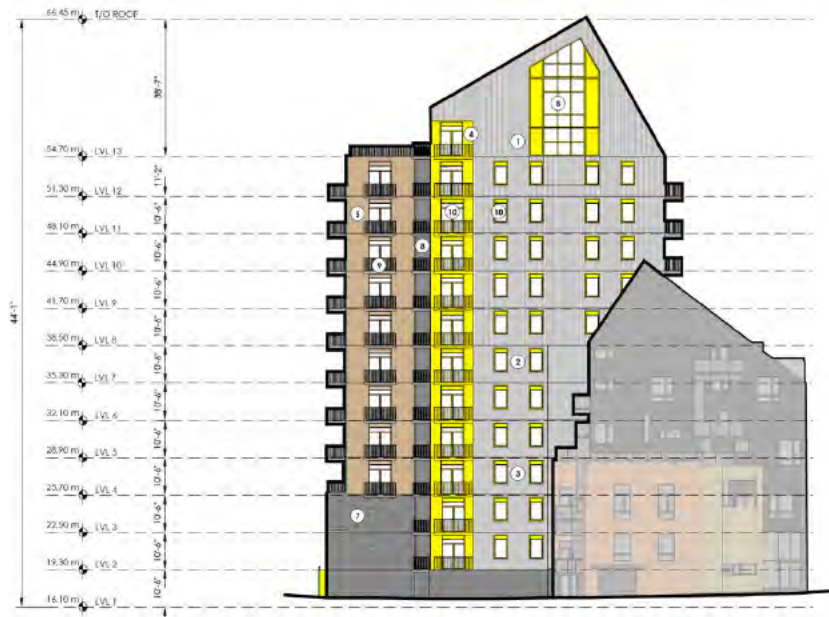
SOUTH (REAR) ELEVATION

The tall and slender form of the new building, with a sloped roof and off-set gable peak facing north and south, draws from both the Tel Lofts immediately to the south, as well as the side gable form of the George and Mary Shiels Residence. It allows for substantial open space to be provided for the heritage buildings to stand distinctively separate, complement them, while being clearly distinguishable.

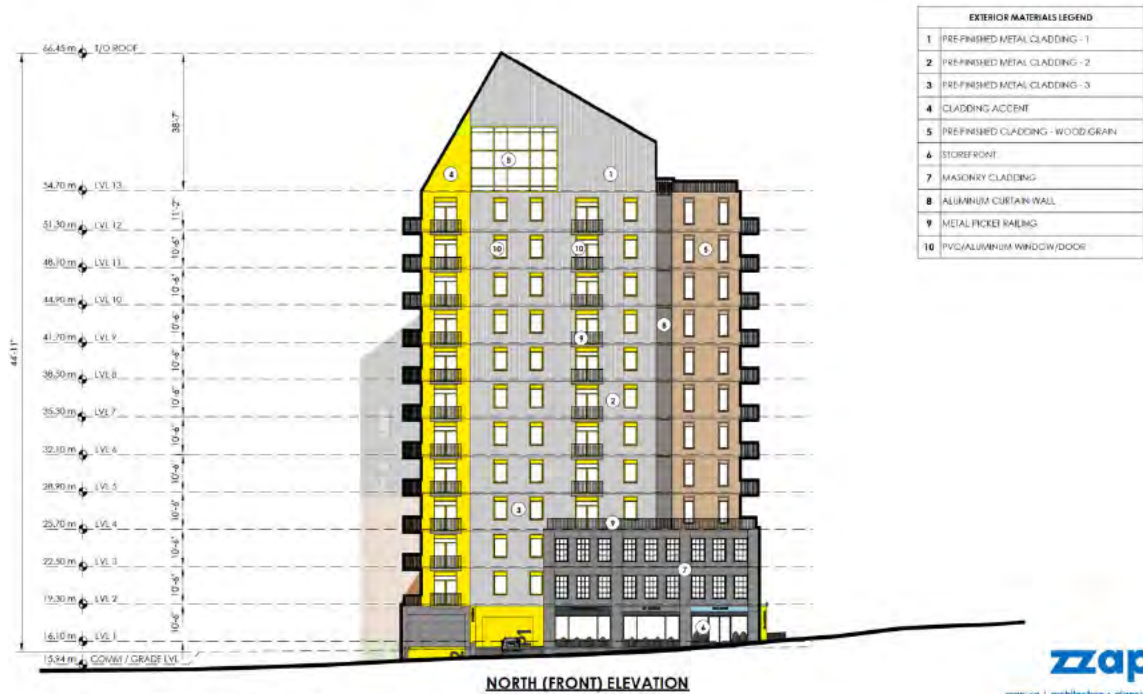
Reference: North Elevation.

The materials used on the tower portion of the new development, consisting of corrugated metal cladding and pre-finished wood-grain panels, with masonry on the lower portion fronting Dundas Street: these contrast with and complement the wood cladding of both the George Mary Shiels Residence and the Alexander and Maude MacKay Residence.

Conclusion: Complementary yet distinguishable.

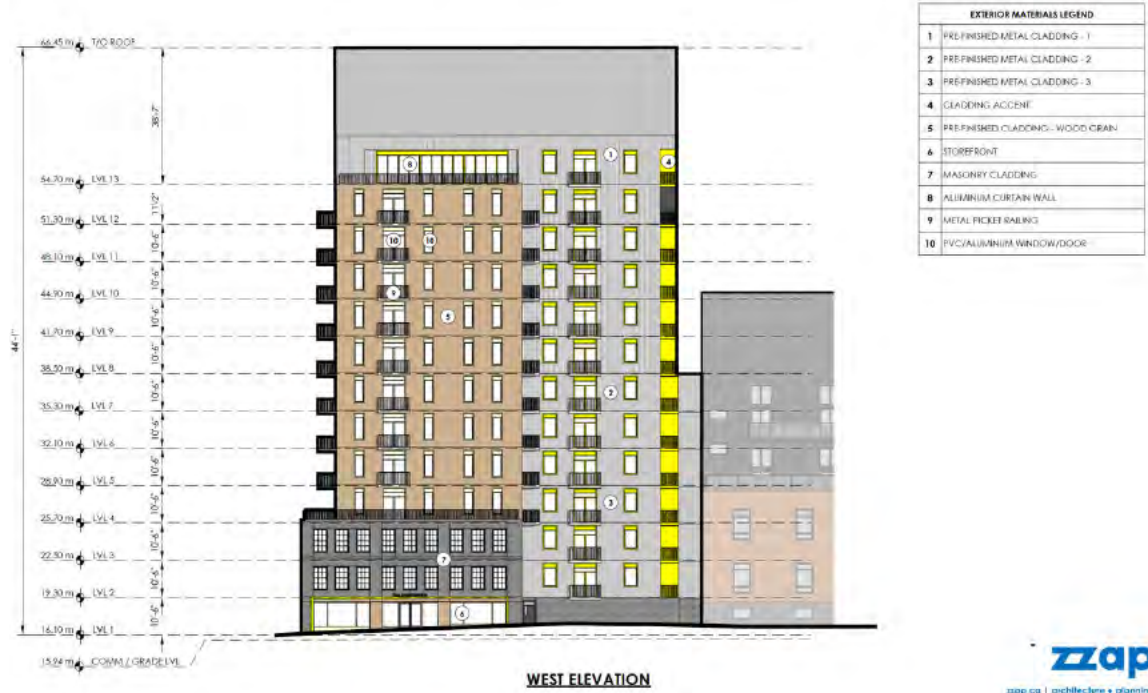
Reference: West Elevation.

The single-set windows on the new development, in both the tower and in the lower section, complement those on the George Mary Shields Residence, which also features most of its windows as single-set. In addition, those on the lower section of the new development, along Dundas Street and on the west side facing the rear of the George Mary Shields Residence, have a multi-pane pattern that is similar to that of the heritage building. The window pattern defined by vertical sections (i.e. those on the “brown” wall faces are narrower) provides an interesting variation in design, compatible to the heritage buildings.

Conclusion: Visually compatible, subordinate and distinguishable.
