SUBJECT: **Case HRTG-2024-00433: Request to Include 6 First Avenue, Bedford in the Registry of Heritage Properties for the Halifax Regional Municipality**

**EVALUATION CRITERIA
FOR REGISTRATION OF HERITAGE BUILDINGS (Revised 2004)**

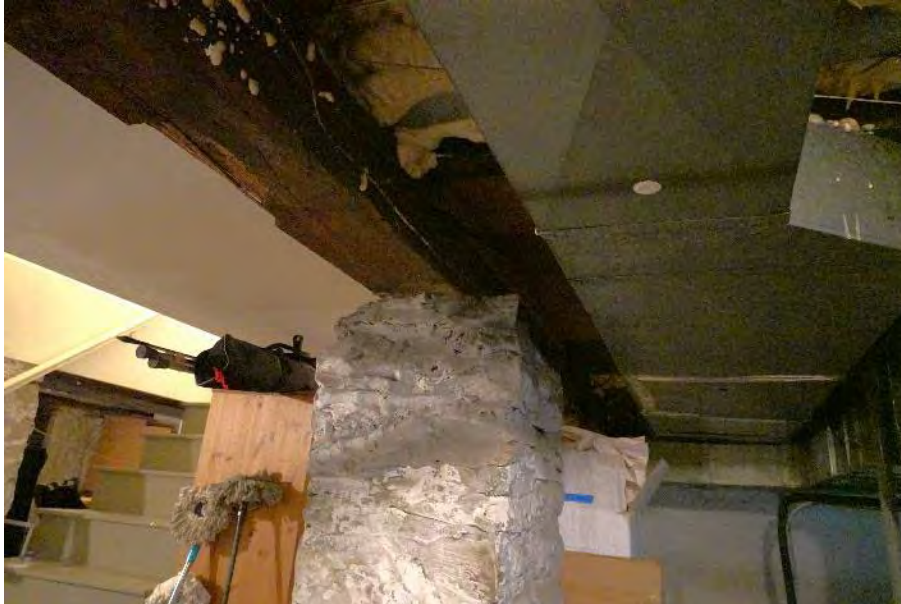
Figure 8: Rock foundation and wood beams as visible in the basement (Staff photo, April 18, 2024)

6 First Avenue is a two-storey, T-shaped building constructed using balloon framing. The house sits on a rock foundation and features three brick chimneys. Its exterior is clad in wood shingles. Balloon framing is a construction method that employs long, continuous studs running from the foundation to the roof. This technique, which utilized dimensional lumber and manufactured nails, allowed for quicker and more cost-effective construction compared to traditional timber framing. Balloon framing, while common in the late 19th century, was gradually replaced by platform framing after the 1930s and is now increasingly rare.

The subject property is a two-storey building of balloon frame wood construction with a T-shape plan. It is built atop a rock foundation. The house features three brick masonry chimneys: one situated on the north side, and the other two positioned on the roofs of the south wing and west wing, respectively. The outside walls are clad with wood shingles. Balloon framing used dimensional lumber and manufactured nails for the frame of the dwelling, and is particularly notable for the long, continuous studs cut from tall, old-growth trees, which run from the foundation to the roof. This framing method allowed for faster and cheaper construction than the traditional timber framing methods that preceded it. Balloon framing was replaced by platform framing from the 1930s onwards and is growing increasingly less common.

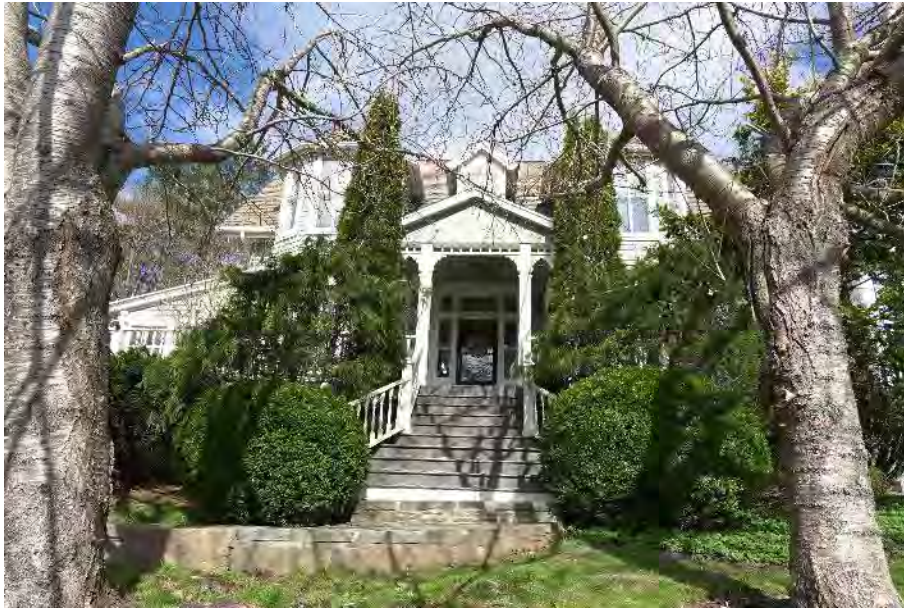
Figure 9: East elevation (Staff photo, April 18, 2024)

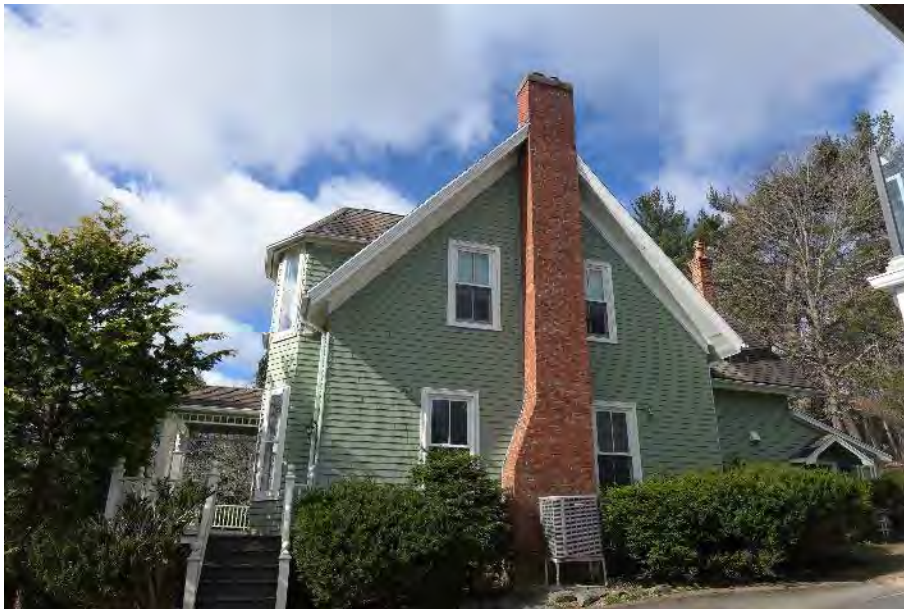
Figure 10: North elevation (Staff photo, April 18, 2024)

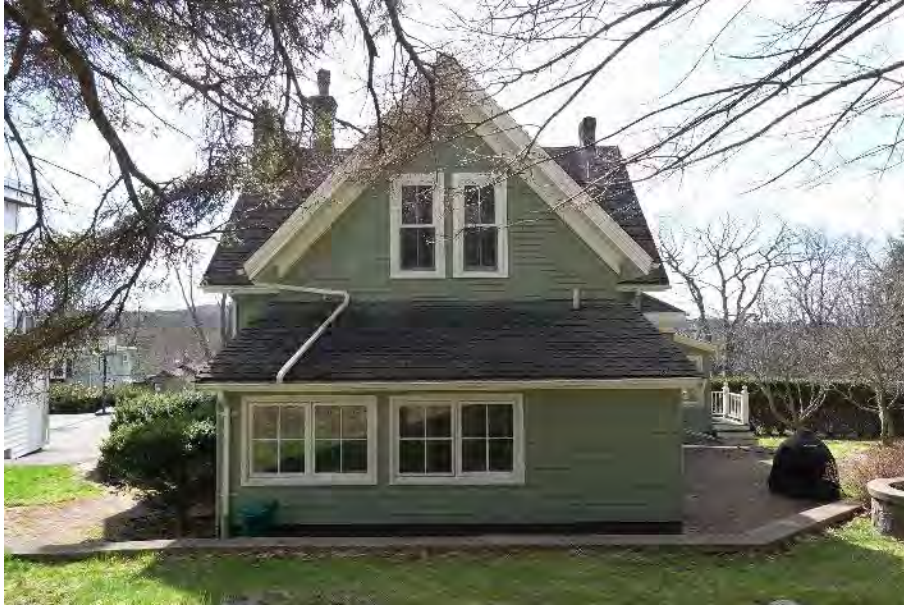
Figure 11: West elevation (Staff photo, April 18, 2024)

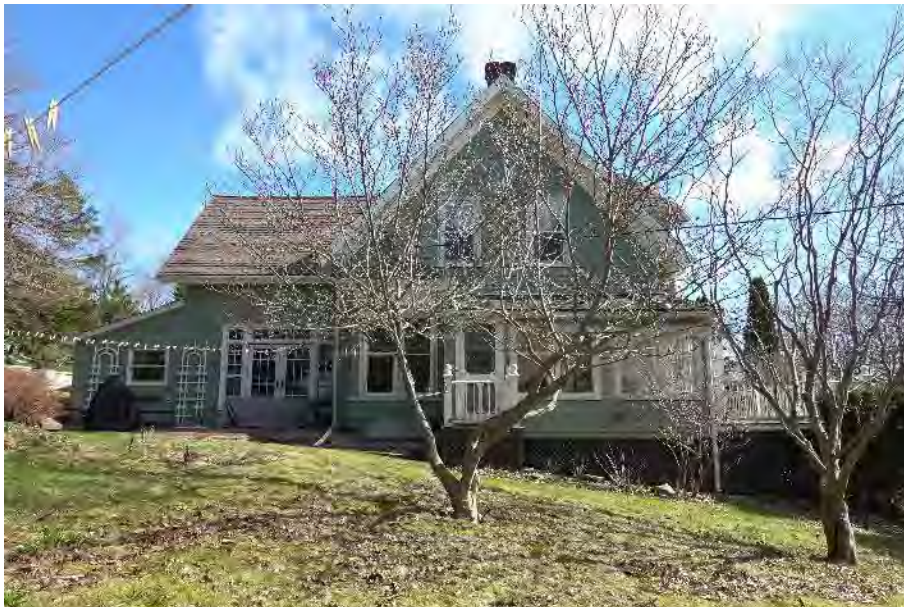
Figure 12: South elevation (Staff photo, April 18, 2024)

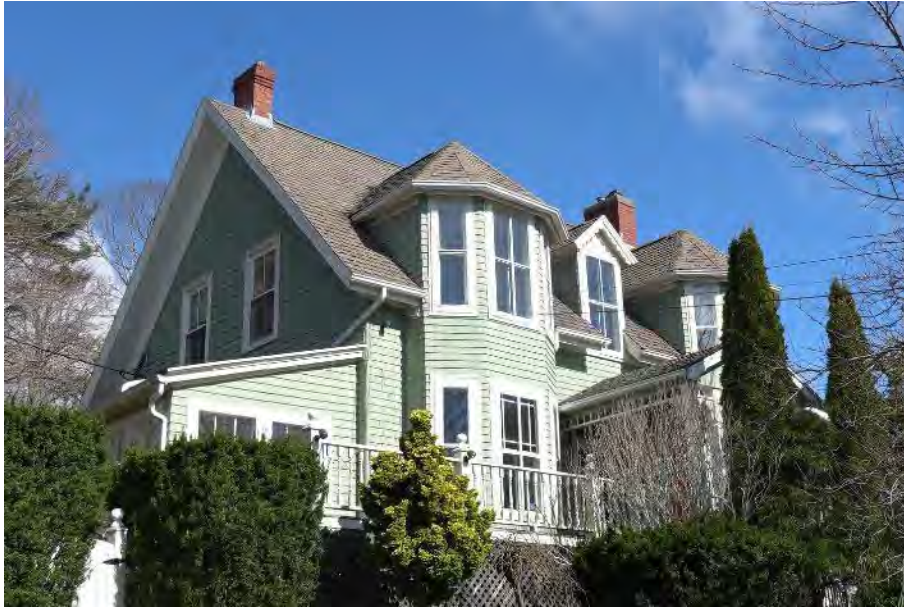
Figure 13: Two-storey, five-sided bay windows with hipped roof, and gabled wall dormer with bargeboards on the east elevation (Staff photo, April 18, 2024)

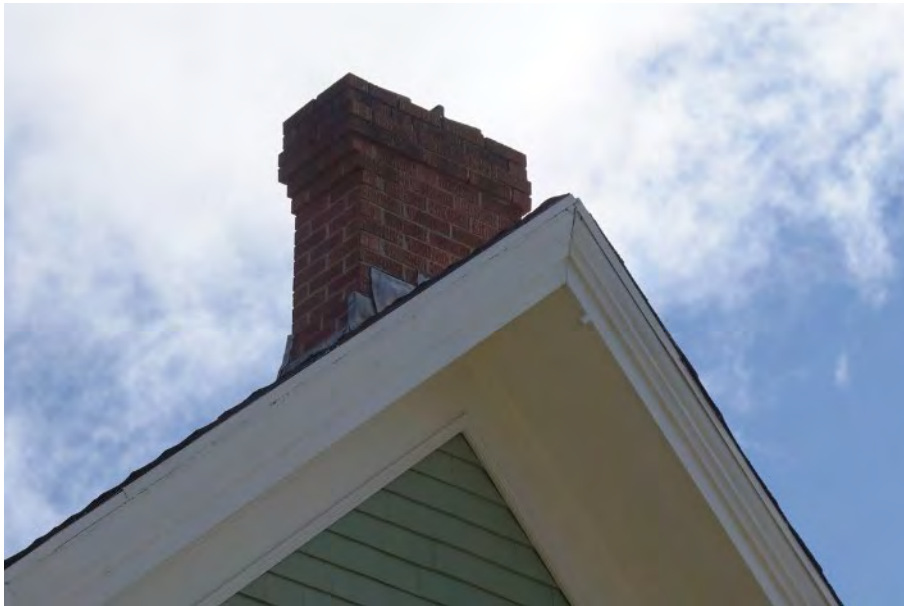
Figure 14: Single-stack brick chimney and moulded fascia and frieze (Staff photo, April 18, 2024)

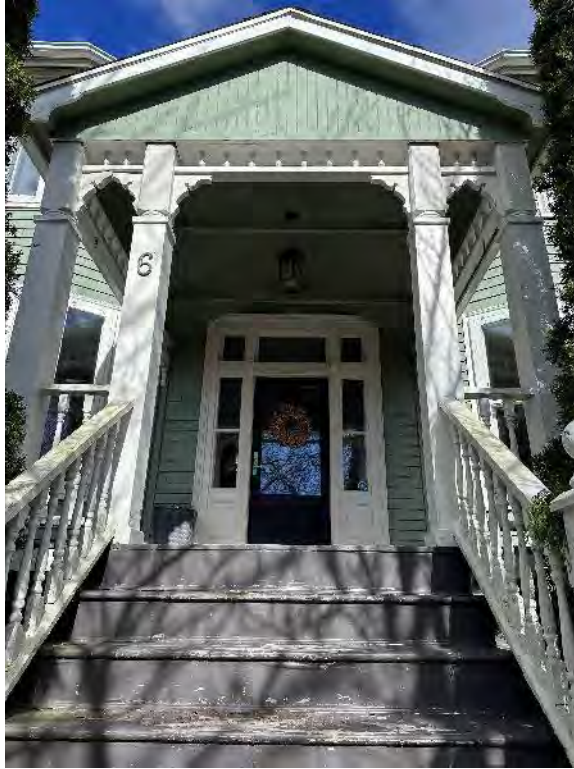
Figure 15: Pedimented porch with fretted railings, bargeboards, brackets, and square posts; Under the porch, the main entry door with side light, transom lights, and decorative panels and trims. (Staff photo, April 18, 2024)

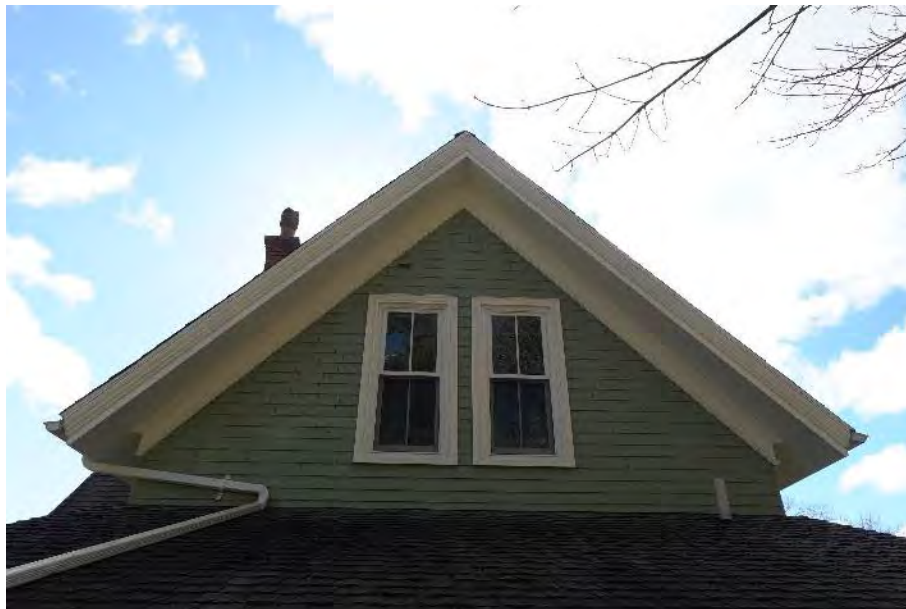
Figure 16: Fascia boards and frieze trims and two tall narrow wood windows on the rear gable (Staff photo, April 18, 2024)

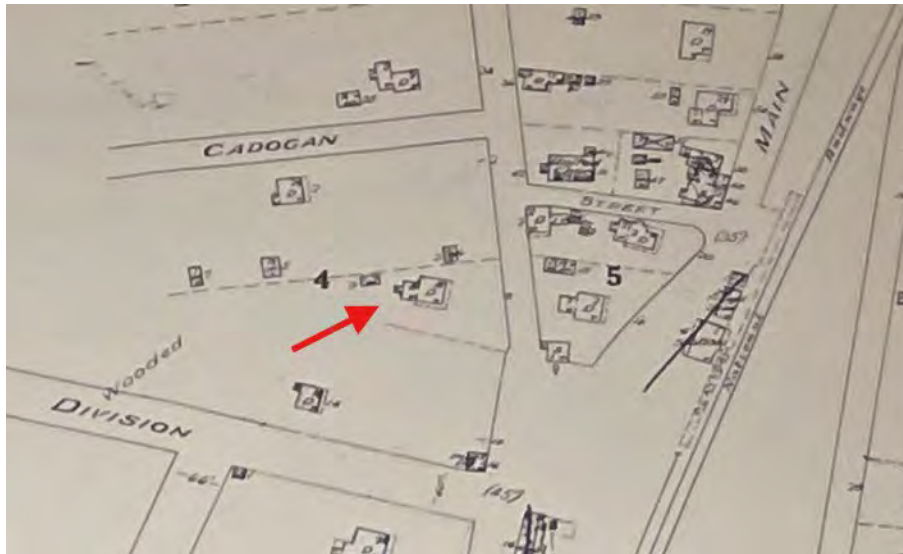
Figure 17: 1926 Fire Insurance Plan of Bedford with the subject property denoted with a red arrow.¹³ The plan indicates that there was a wraparound porch or deck on the south and east elevations of the subject property

The original layout was a symmetrical T-shape plan, which remains largely unchanged (Figure 17). There would have previously been a wraparound porch or deck on the south and east elevations, which is common in the Bedford area and typical of the Queen Anne style. Two additions were added to the subject property. One is attached to the rear elevation (Figure 18), and another on the south elevation, which partially enclosed the wraparound porch (Figure 19). The south addition is likely an earlier alteration, as it features a more traditional window design with wood storm windows. The rear addition was a later alteration with modern windows. Except potentially covering some original windows, these additions do not significantly impact the character defining elements of the subject building. Other modifications noted during visual inspection include the addition of modern French doors with sidelights and transom on the south side of the rear addition (Figure 21).

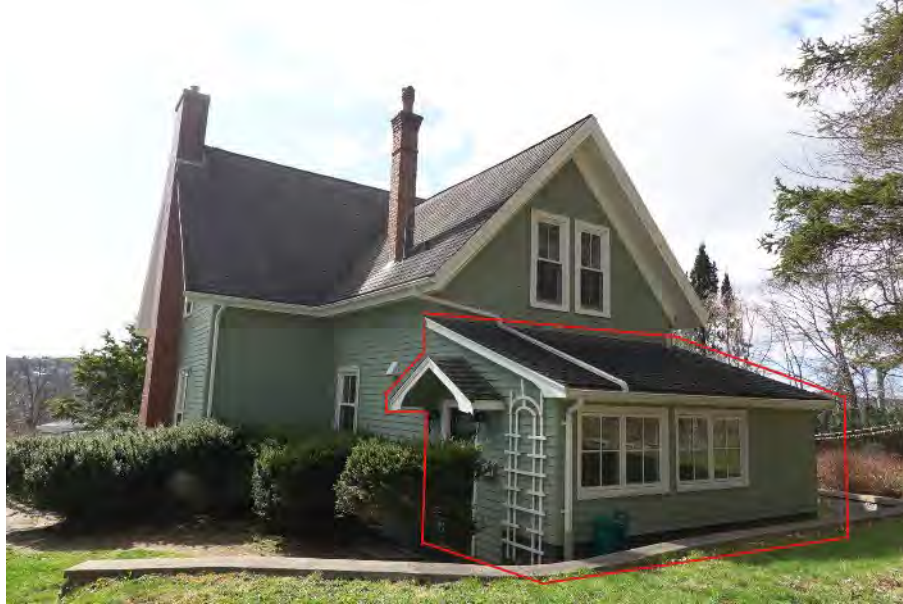
Figure 18: Rear addition highlighted with redlines (Staff photo, April 18, 2024)

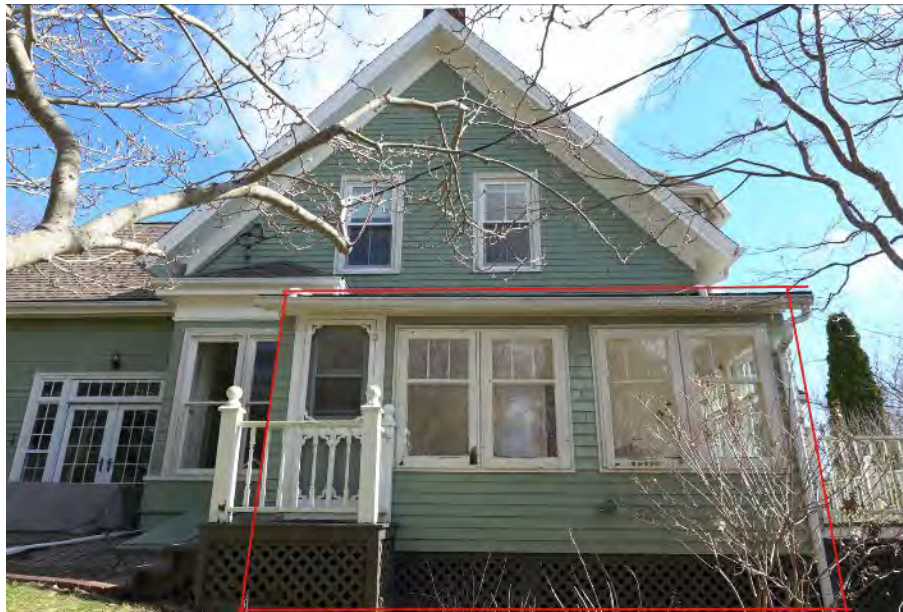
Figure 19: South addition highlighted with redlines, recognized as a character-defining element as an early alteration (Staff photo, April 18, 2024)

A bay window is located near the south addition (Figure 20), and may be a later alteration, as it disrupts the building's symmetrical plan. This bay window features a hipped roof, cornice trim, and wood windows, which are in keeping with the original architectural elements of the house. If the bay window is not original, it would still be eligible for inclusion in the character defining elements per Standard 2 of *the Standards and Guidelines for the Conservation of Historic Places in Canada (2nd Edition)* and does not detract from the architectural integrity of the subject dwelling. Standard 2 also applies to the south addition with wood fenestration (Figure 19).

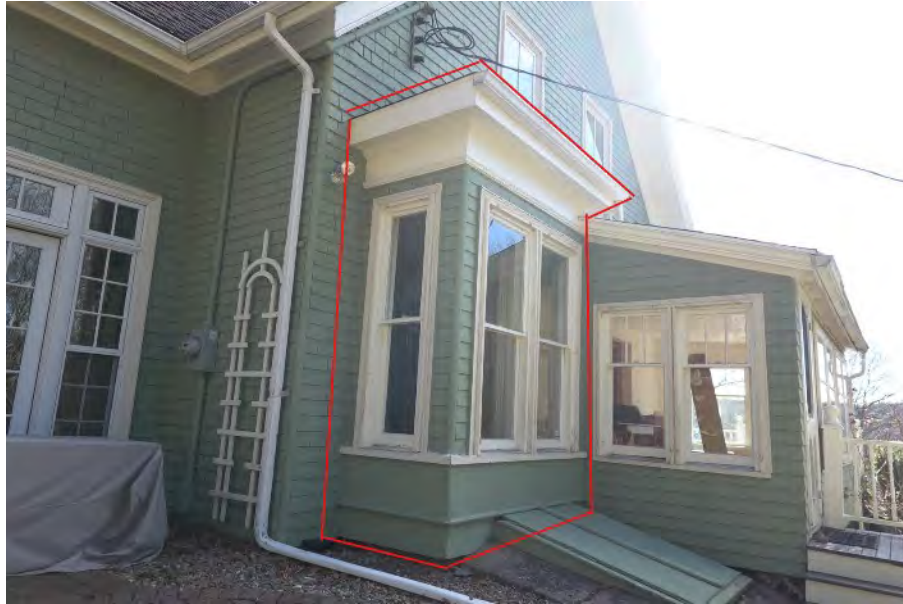
Figure 20: Box bay window adjacent to the south addition, with a hipped roof, cornice trim, and wood windows, recognized as a character-defining element (Staff photo, April 18, 2024)

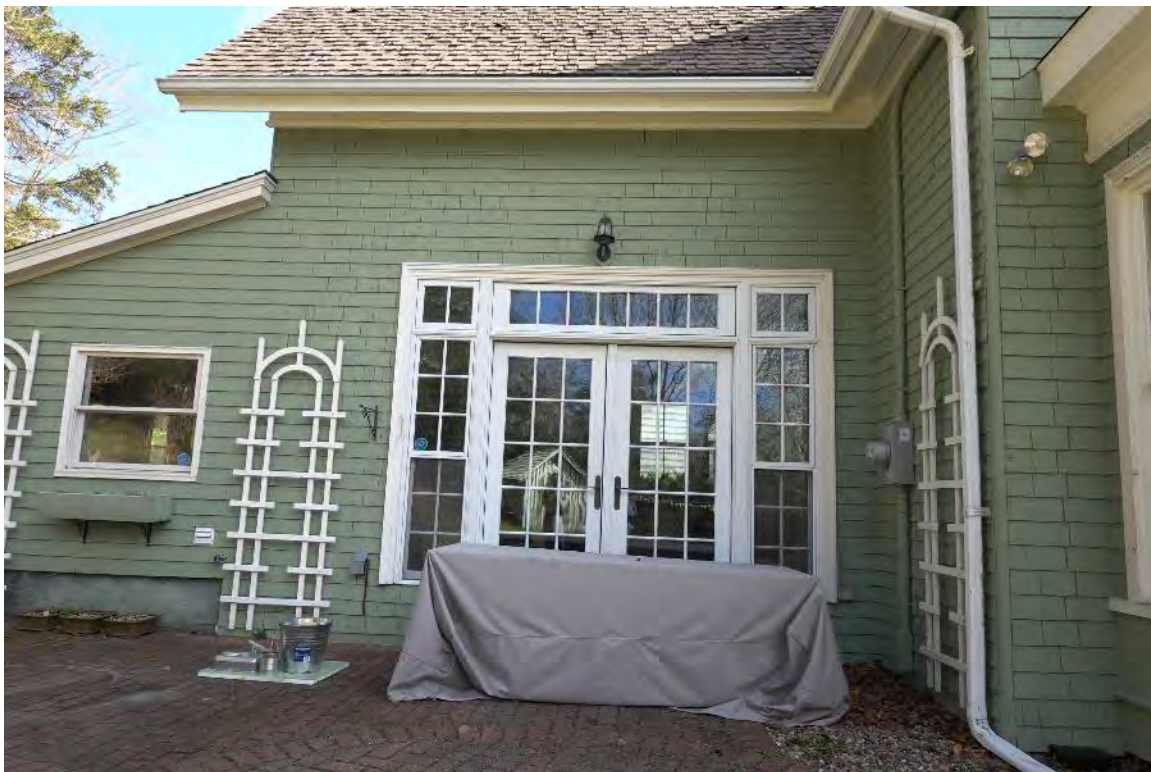
Figure 21: Two French doors with surrounding lights were added to the south side of the rear wing (Staff photo, April 18, 2024)
